ACCIDENT TO THE

MOBILE OFFSHORE DRILLING UNIT

MAERSK VICTORY

ON NOVEMBER 16 1996

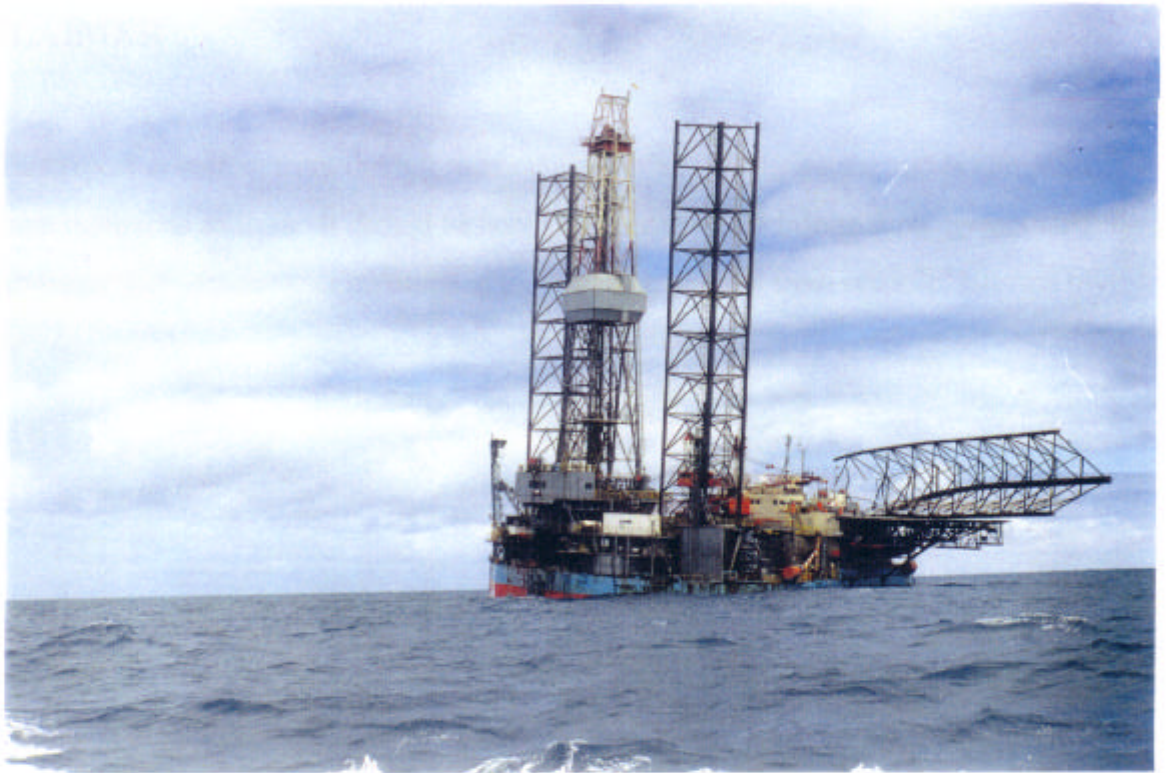
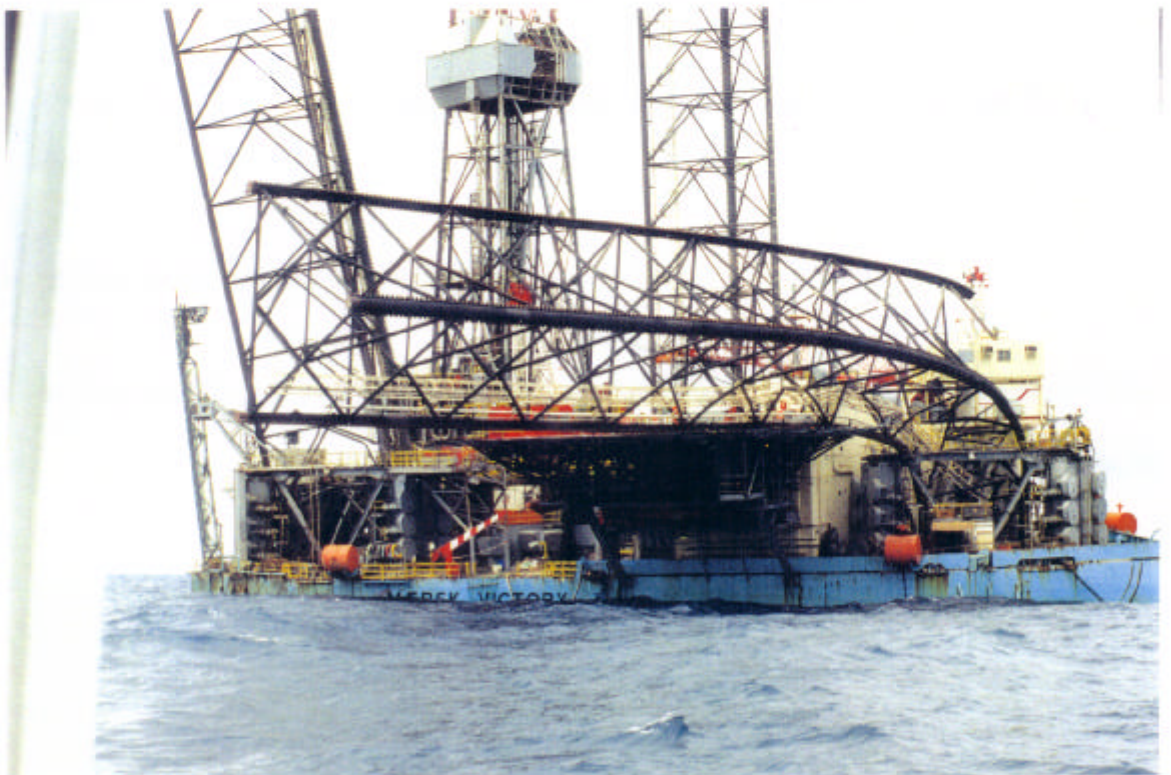
***MAERSK VICTORY* AFTER THE ACCIDENT**

Photographs taken on November 22 1996
