Service Letter

SL07-483/HRR
August 2007

**Condition-based Piston Overhaul
MC/MC-C and ME/ME-C type engines
Container Vessels, Bulk Carriers and
vessels with similar trade pattern
Action Code: WHEN CONVENIENT**

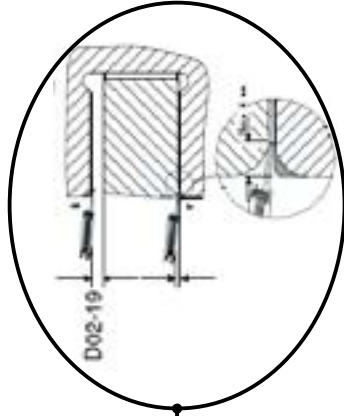
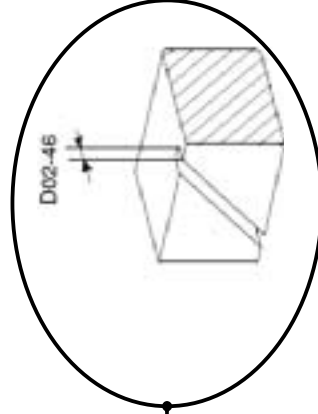
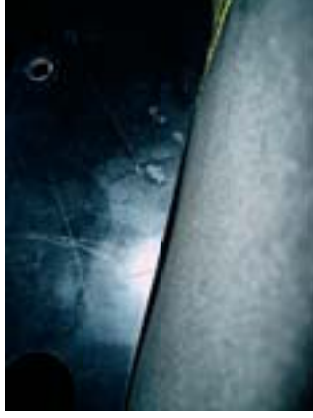
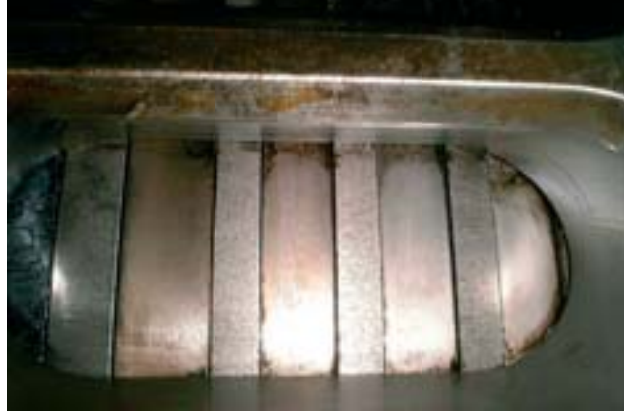
Fig. 1

- Piston ring wear (ref. instruction book).
- Max. amount of hot corrosion of piston top allowed on the centre part (where it is normally highest) is 9/12/15 mm on, respectively, 80/90/98-bore engines.
- Ring groove clearance.
Max. recommended clearance is 1.0 mm on the 80 and 90-bore engines, and 1.1 mm on 98-bore engines
- Sticking, broken or collapsed piston rings or leaking pistons.
- Macro-seizures on piston ring running surfaces.

When is piston overhaul necessary?

- Before piston burning reaches the max. allowed

- Before ring groove clearance reaches the max. allowed

- In case of macro-seizures on the rings (scuffing)

- When the wear on the top piston ring has reduced the CL-grooves to the minimum

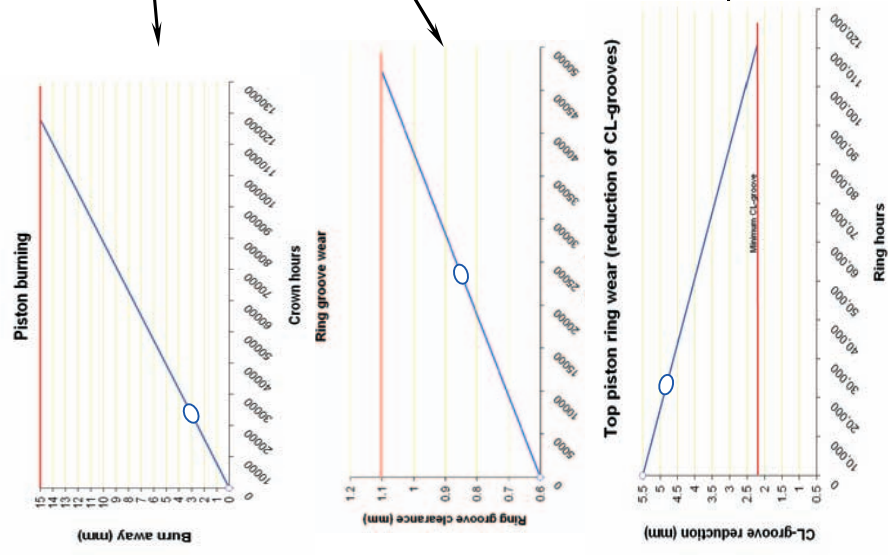
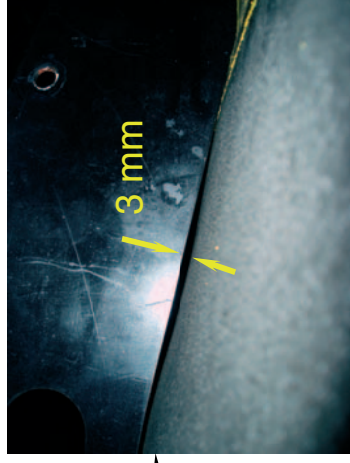
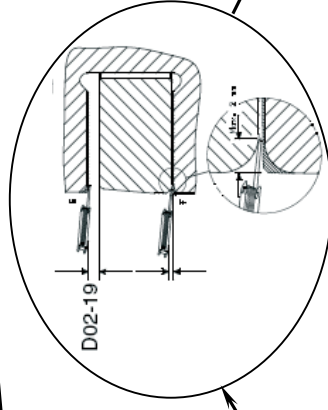
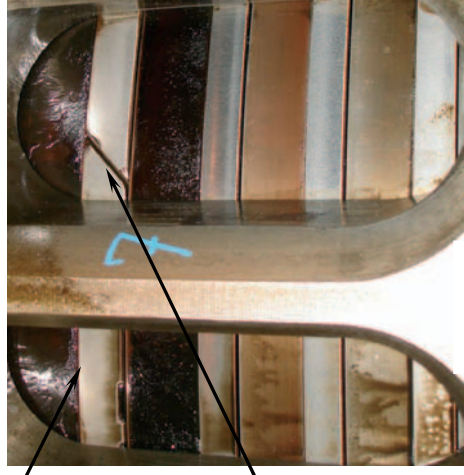
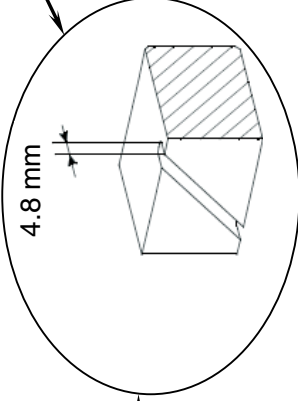
Fig 2

Top piston ring wear, defined by measuring the remaining depth of the CL grooves, ring groove clearances, measured with a feeler gauge, and estimated piston burnings on large-bore engines, measured by means of a template via the scavenge ports, should be recorded. Our standard sheets "Cylinder Condition Report" and "Inspection through Scavenge Ports" can be used, forming the ideal documentation for later review and for making trend curves for future wear forecasts (see the example in Fig. 2).

How to judge, example from a 10K98MC-C with 23,500 running hours without overhaul

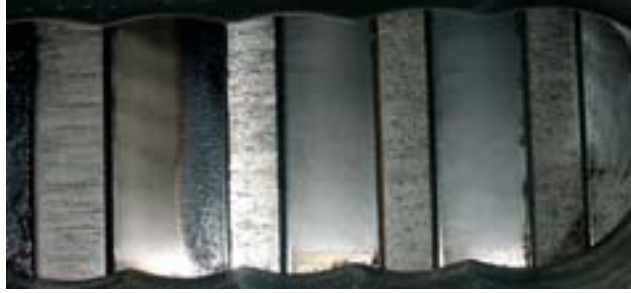
Fig. 3. Totally scuffed unit. Lubrication should be increased to maximum until overhaul is convenient with regard to the schedule of the ship. Due to the friction heat developed, the piston rings get hardened, and the wear rate of the liner increases significantly. However, the hardening protects the rings, which is why the operation may be continued safely until next convenient port stay.

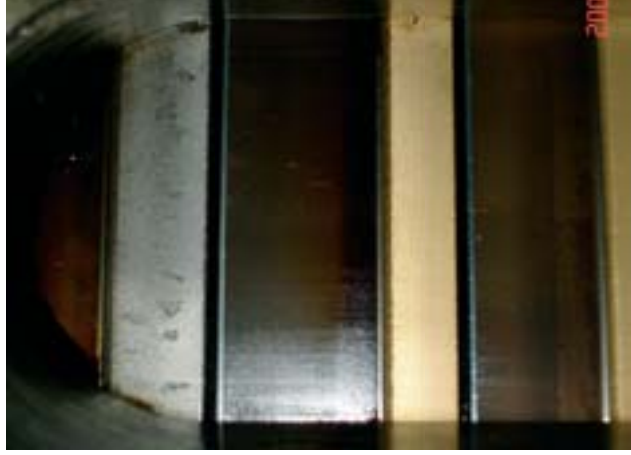
Fig. 4. Unit with micro-seizures on the top ring as a result of metal-to-metal contact. Should be counteracted by temporarily increased lubrication. It is important to lower the lubrication to normal as soon as the active m-z-attack is stopped. Note that old, not active, m-z-marks remain visible long after the attack has stopped and do not call for increased lubrication.

In case of micro-seizures (mz), lubrication should be increased temporarily according to the standard lubrication guidelines. However, it is important to lower the lubrication to normal as soon as the active mz-attack is stopped. It should be noted that old, not active, mz-marks remain visible long time after the attack has stopped, which does not call for increased lubrication. Figs. 4 and 7.

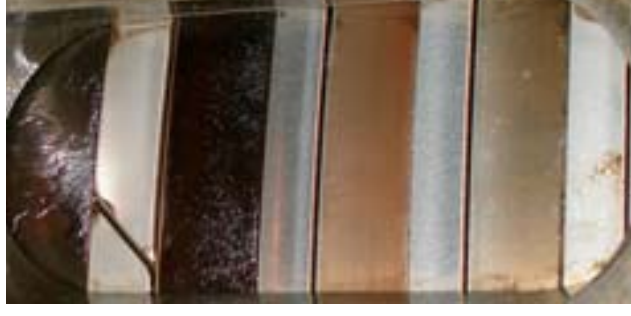
Fig. 5. Unit with 23,500 hours without piston overhaul. Note that most of the rounding is still intact, indicating that only $\frac{1}{4}$ of the wear potential is used. Further, the measurements above from the same unit shows that only $\frac{1}{2}$ of the ring groove wear potential is used, and the rate of burnings on the piston top is insignificant. Consequently, overhaul of that unit is not needed at this stage.

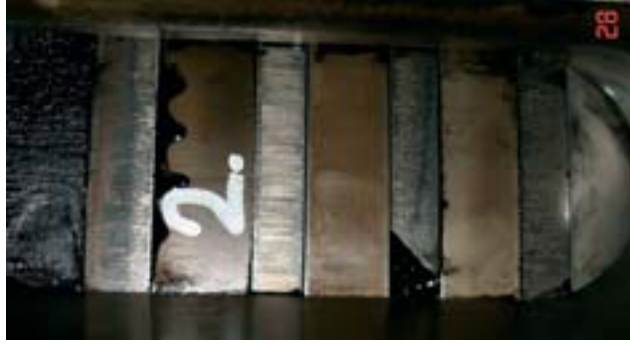
Fig. 6. Totally scuffed unit. Lubrication should be increased to maximum until overhaul is convenient with regard to the schedule of the ship. Due to the friction heat developed, the piston rings get hardened, and the wear rate of the liner increases significantly. However, the hardening protects the rings, which is why operation may be continued safely until next convenient port stay.

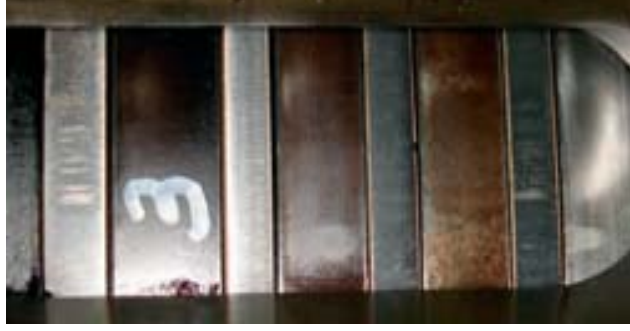
Fig. 7. Unit with micro-seizures on the top and bottom rings as a result of metal-to-metal contact. Should be counteracted by temporarily increased lubrication. It is important to lower the lubrication to normal as soon as the active mz-attack is stopped. Note that old, not active, mz-marks remain visible a long time and do not call for increased lubrication.

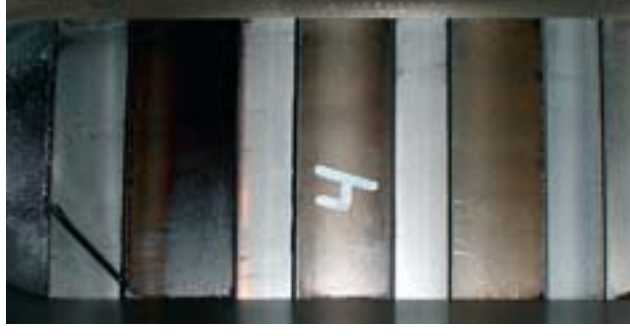
Fig. 8. Unit running very well after 20,021 running hours. Note that the last remains of the alu-coat are still visible on the lower edge, indicating remaining rounding left. This means that the ring wear is less than 2 mm out of possible 3 mm. Consequently, many more hours are left from the point of view of wear.
