MTPNO864, Hull Ships in operation Technical Information

Technical Information Newsletter No. 3/2007

Welding of cracks in rudder blades.

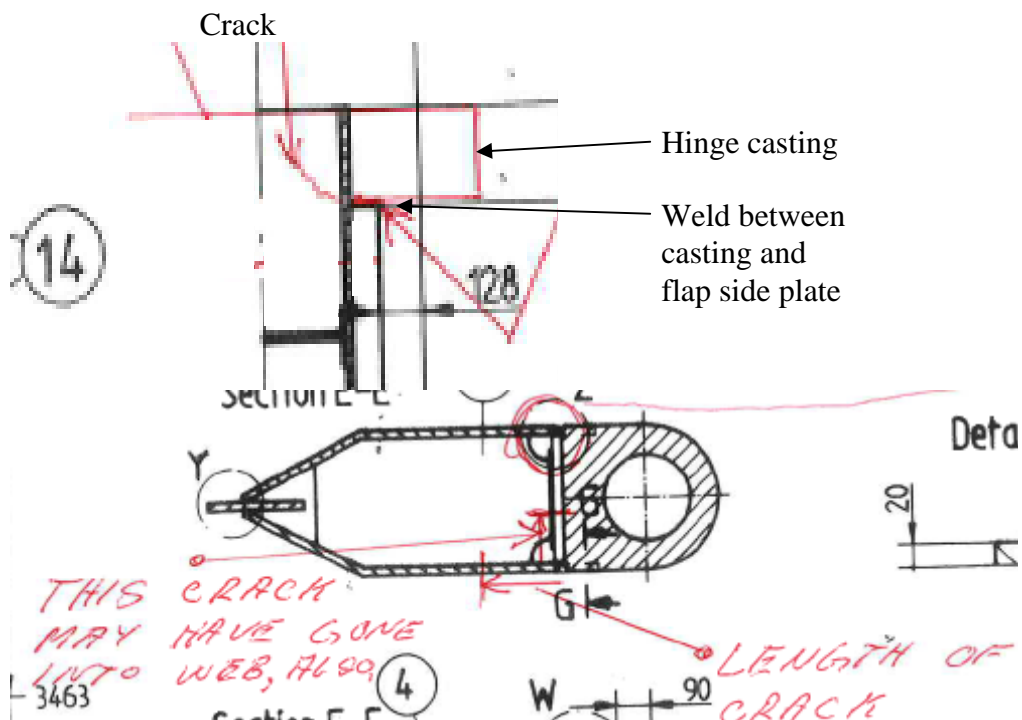
6 months earlier several cracks in the flap had been welded up by gouging and re-welding. Parts of the cracks were accessible from the back side where a ceramic backing was used during welding. One crack at the top of the flap was a bit longer and the welding was against a hinge bearing casting, thus making it difficult to fit a ceramic backing at this point. Also the end of the crack was extending past the vertical web making it impossible to back weld or inspect the root of the weld.

It is possible that, when this weld was re-welded, the crack had also propagated in the vertical web. (See sketches below) This crack could then easily propagate back out towards the repaired weld and cause it to crack again very quickly.

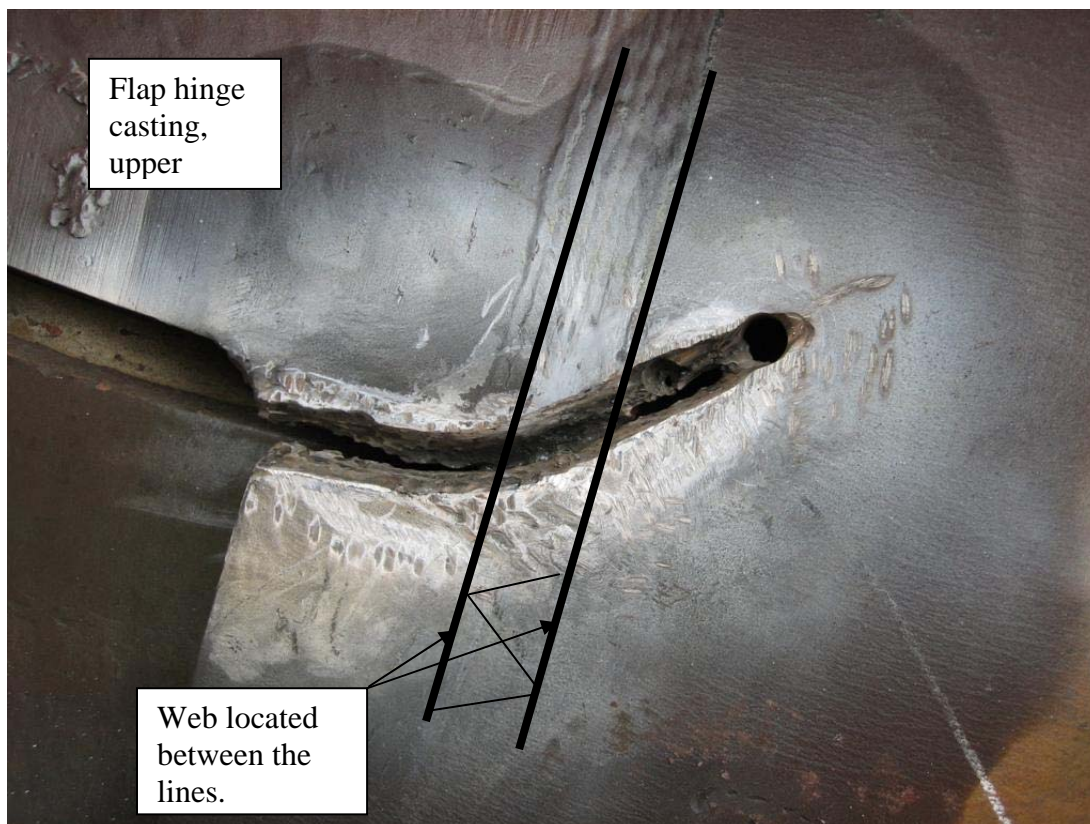
Picture below shows the crack after it had been gouged out. The web plate as can be seen on sketch above is behind the vertical weld in the picture below.

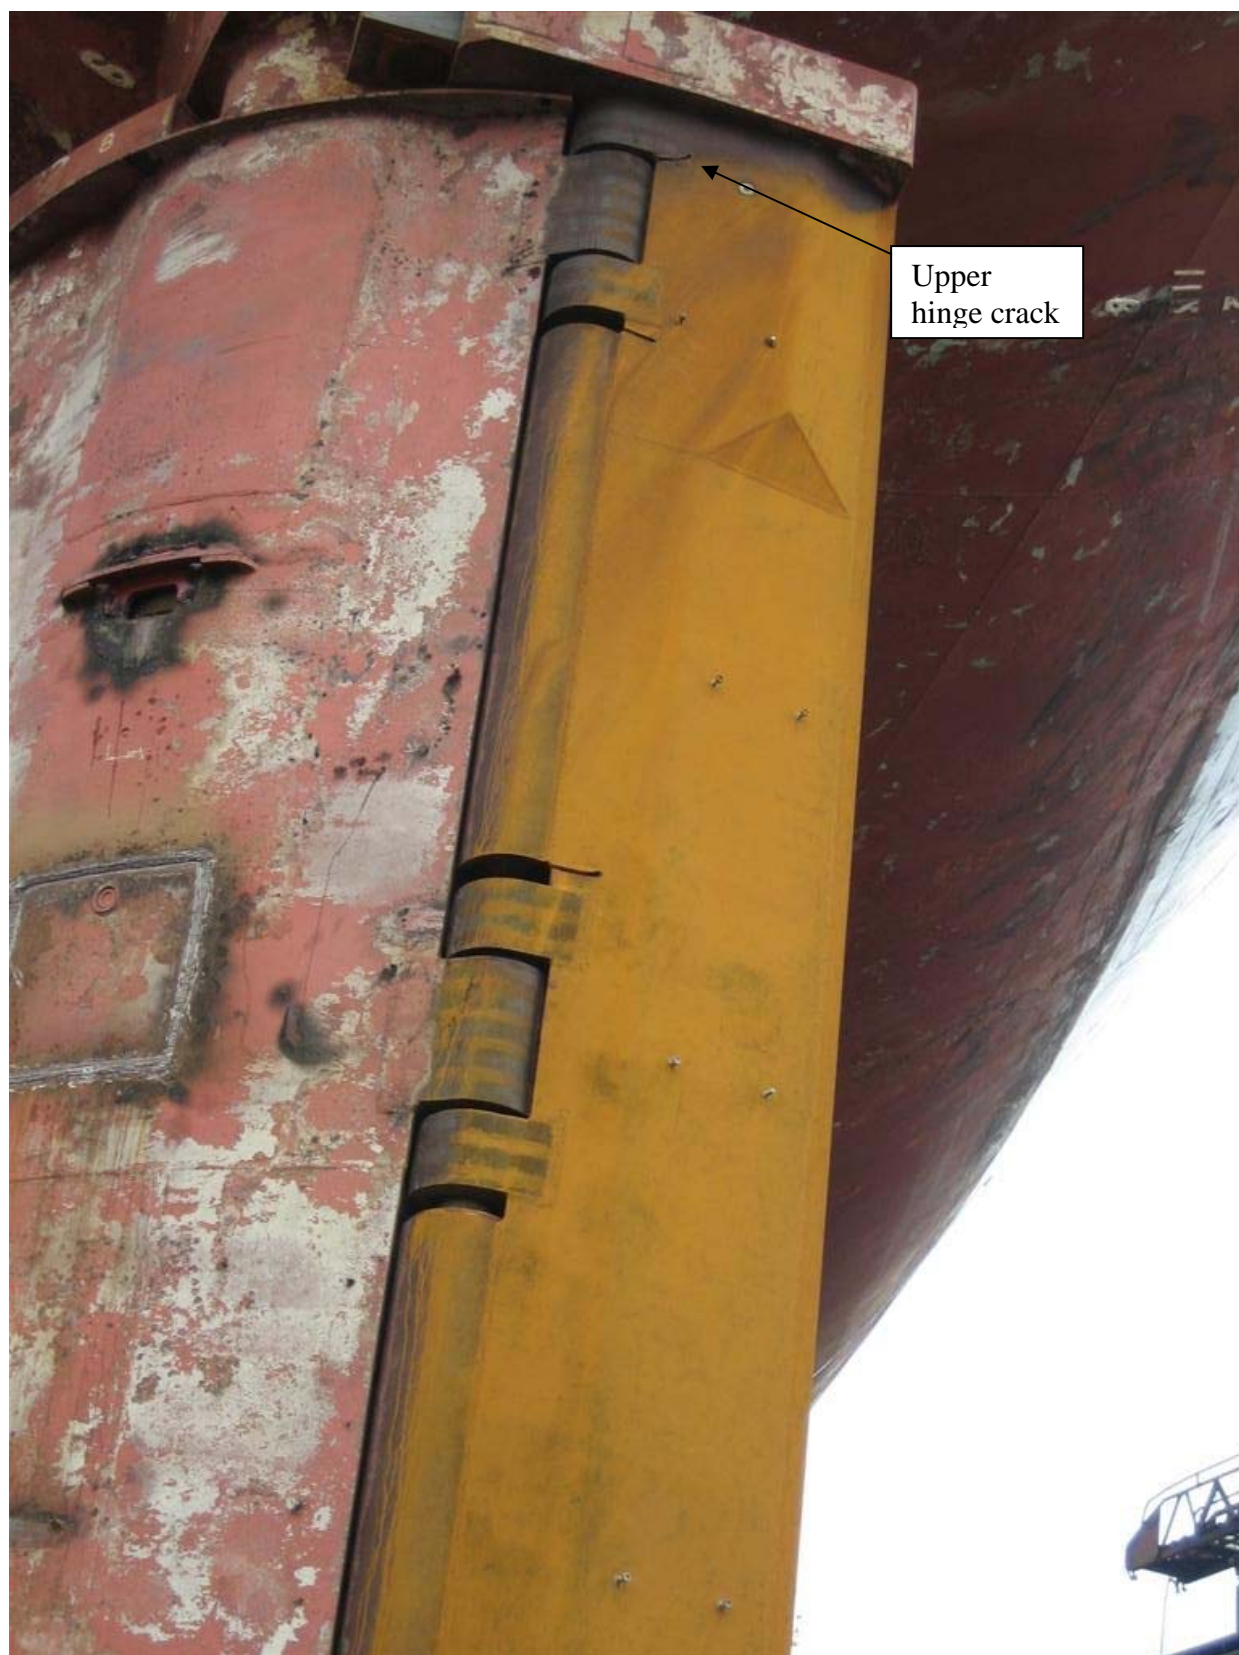
Managers of a vessel reported that the upper part of the flap of a Becker type rudder was missing. Diving survey revealed that the upper half of the flap had broken off just above the middle hinge. The lower half was still intact but just hanging loose without any function.

Picture below shows the flap with the crack, which may be seen right at the top. Two more, slightly shorter cracks may be seen further down.

The vessel proceeded with tug assistance to port where temporary repairs were carried out consisting of welding flat bars across the remaining part of the flap and the blade, thus locking the flap so that the rudder would temporarily function as a normal rudder. CC for max 3 months given and a steering test was carried out before departure to assure adequate rudder function.

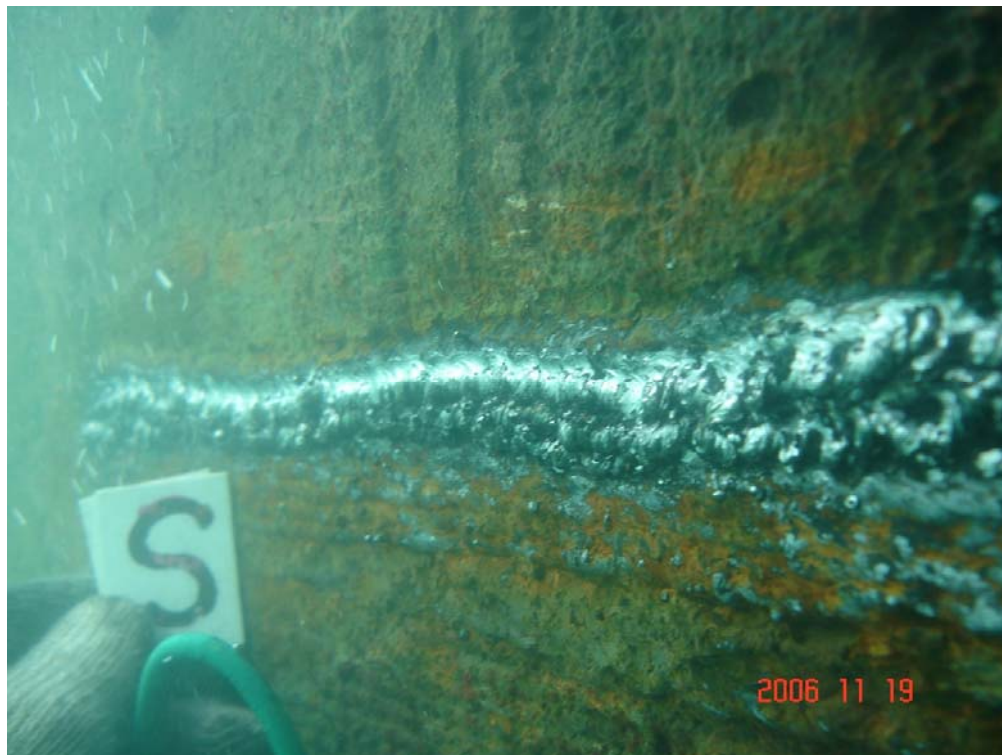
A second recent case was picked up during report review at MTP. In this case a 500 mm long crack in the rudder blade in way of the recess for lower pintle bearing of a semi spade rudder was welded up using underwater welding and given a CC till next docking, 2.5 years into the future.

First of all underwater welding is only acceptable as temporary repairs for a short time, maximum 3 months.

Secondly, a temporary repair of highly stressed areas of a rudder should not be given 2.5 years in any case. Max 3 to 6 months, depending on the severity and length of cracks, would be the most we should normally grant.

Appearance of under water welding of the crack

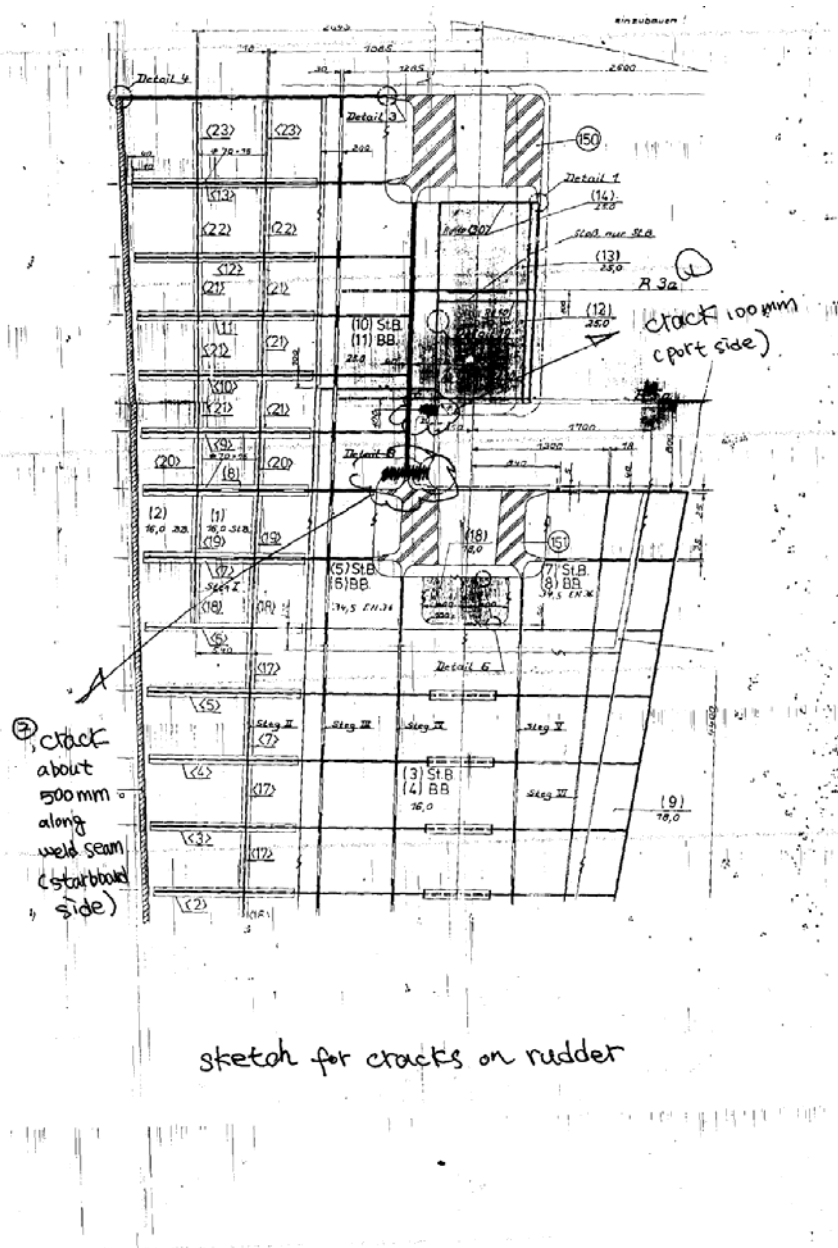
Position of cracks

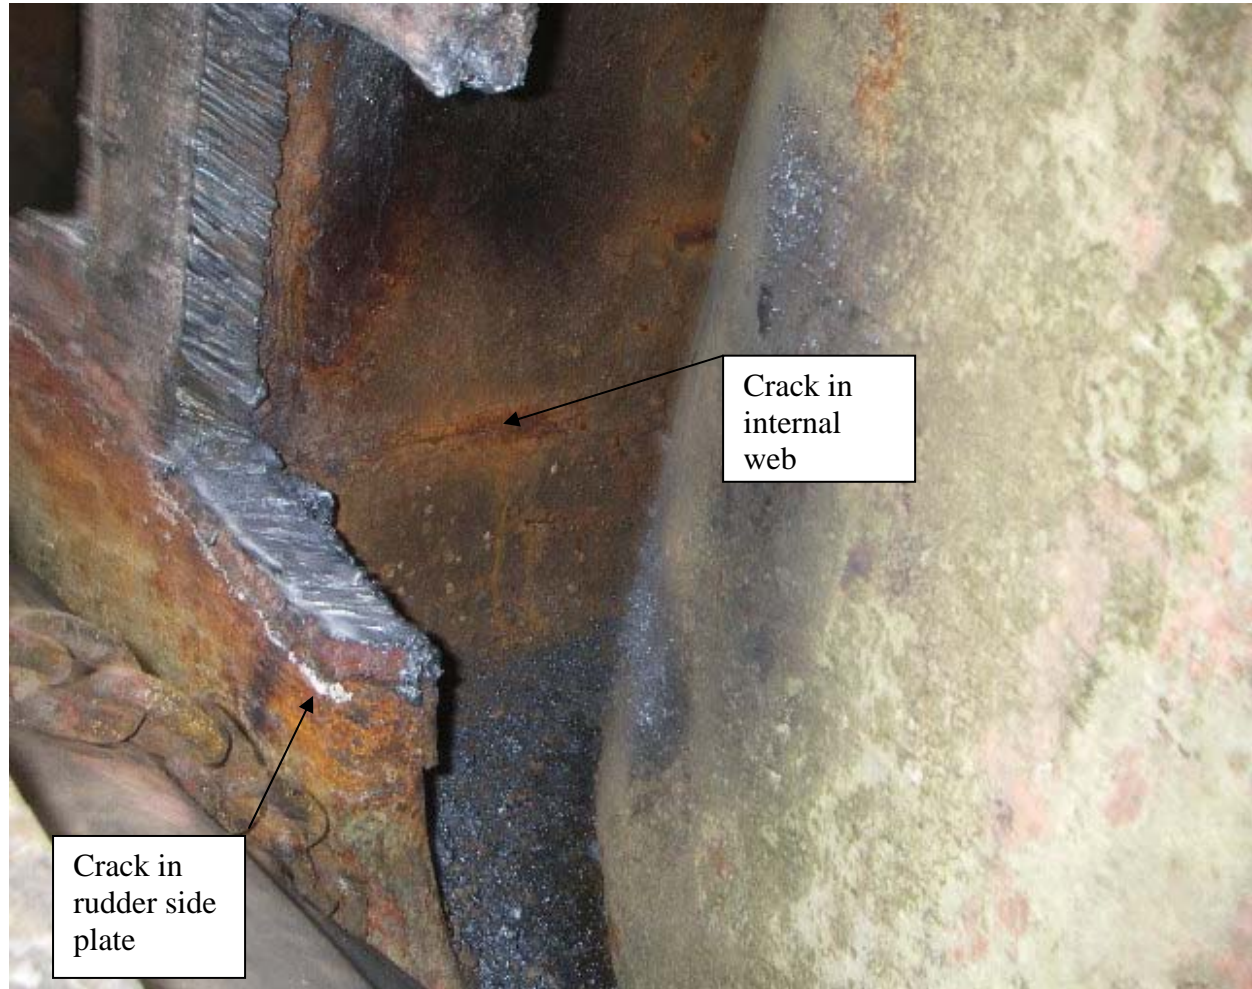
This case also shows that the crack in the rudder side plate was welded (since it is clearly visible) but the internal web, which in this case was 40 mm thick, was not considered.

The owners were talked in to docking the vessel, and it turned out that the vertical web was also cracked, by approx 200 mm. The underwater welds had cracked again after only less than 3 months.

Crack in rudder side plate and web

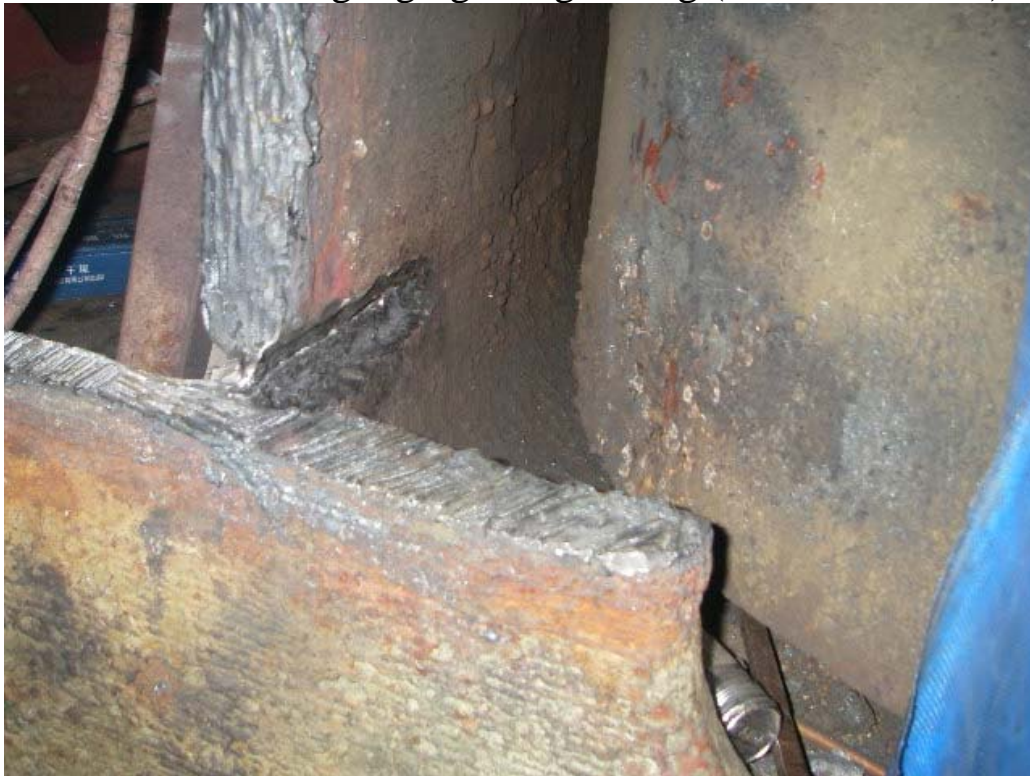
Crack in web after gouging and grinding (from both sides)

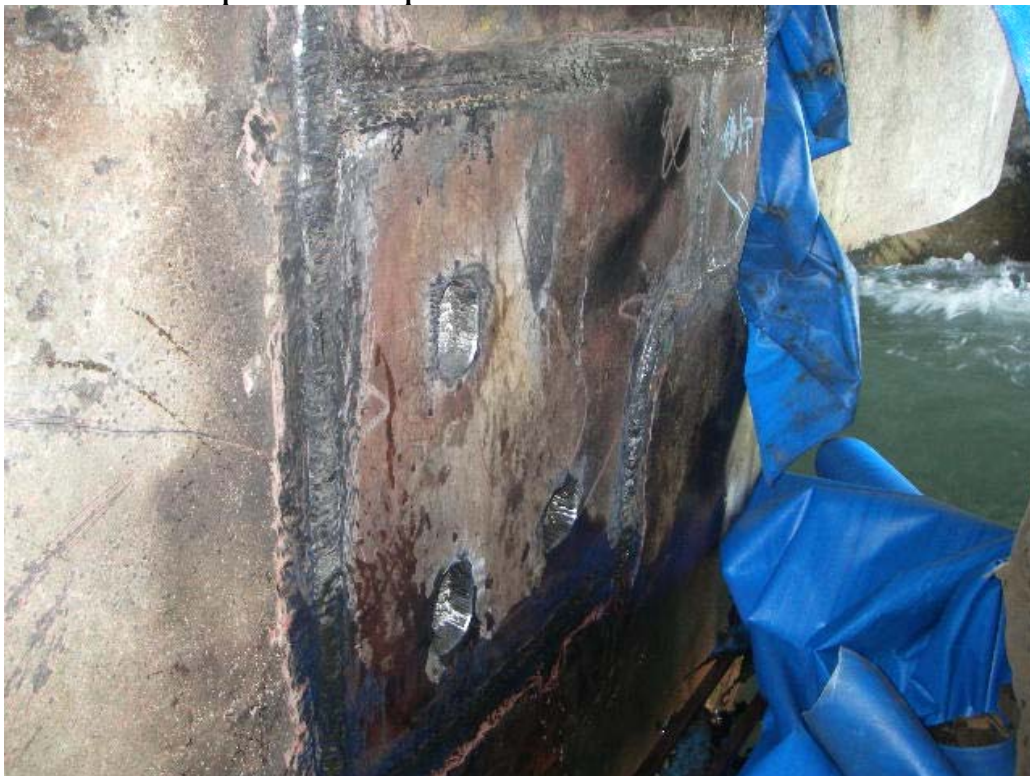
Rudder side plate after plates inserted

If the cracks have occurred more than once, it is advisable to insert a new plate and to gain access to the internal structure to weld any cracks that may have occurred here. See attached repair proposal from IACS repair guideline for rudders.

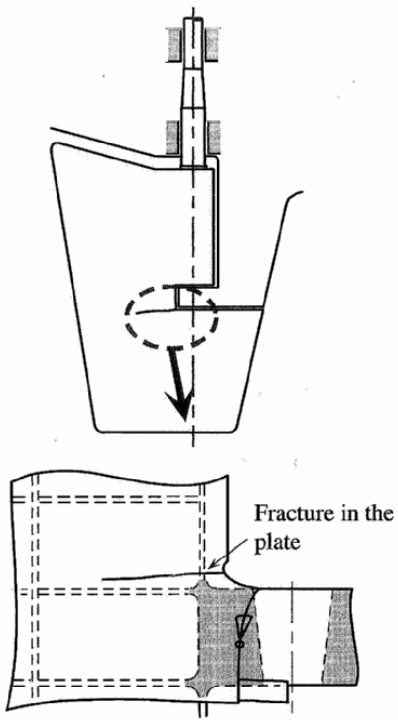
PART 2	Fore and aft end regions	EXAMPLE No.
AREA 3	Stern frame, rudder arrangement and propeller shaft support	5
Detail of damage	Fractures in the rudder plating of the semi-spade rudder extending beyond the vertical web	
Sketch of damage	<div style="display: flex; justify-content: space-around;"> <div style="text-align: center;">

<p>Fracture in the plate</p> </div> <div style="text-align: center;">
