Lloyd's Register *Technical Papers*

**Some recent experience with
double hull tankers**

by **J. S. Carlton**

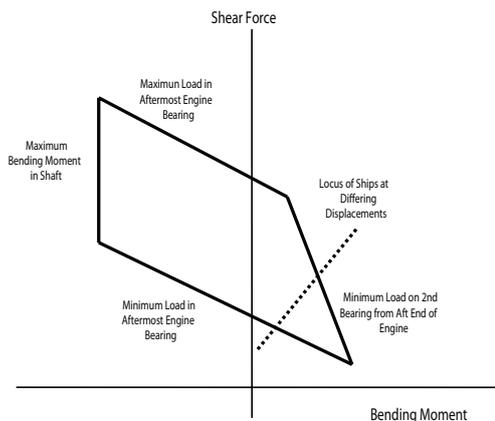
Figure 1: Typical Slow Speed Diesel Engine Coupling Loading Diagram

At the forward end, engine builders have prescribed envelopes of shear forces and bending moments, a typical example of which is shown in Figure 1. Limitations of the type shown are based on the notion of rigid supports for the crankshaft bearings and, in practice, some variability is normally permitted to allow for the flexibility of the crankshaft bearing system. In addition to these bending moment and shear force requirements, the thermal distortion of the diesel engine has to be taken into account as does the internal reactions of the loads within the engine: these reactions include the loadings on the crankshaft introduced by engine components, for example those with cam shaft chain drives whose loadings tend to be distributed between the No. 1 and No. 2 bearings. The internal misalignment which occurs over the aftermost three bearings also tends to reduce the static load on the No. 2 bearing. Furthermore, shaft alignment design calculations frequently do not take account of hull deflection; this often being done by implicit factors rather than explicit calculations.
