Gulf of Mexico Oil Spill

What happened and what is being done to solve the problems?

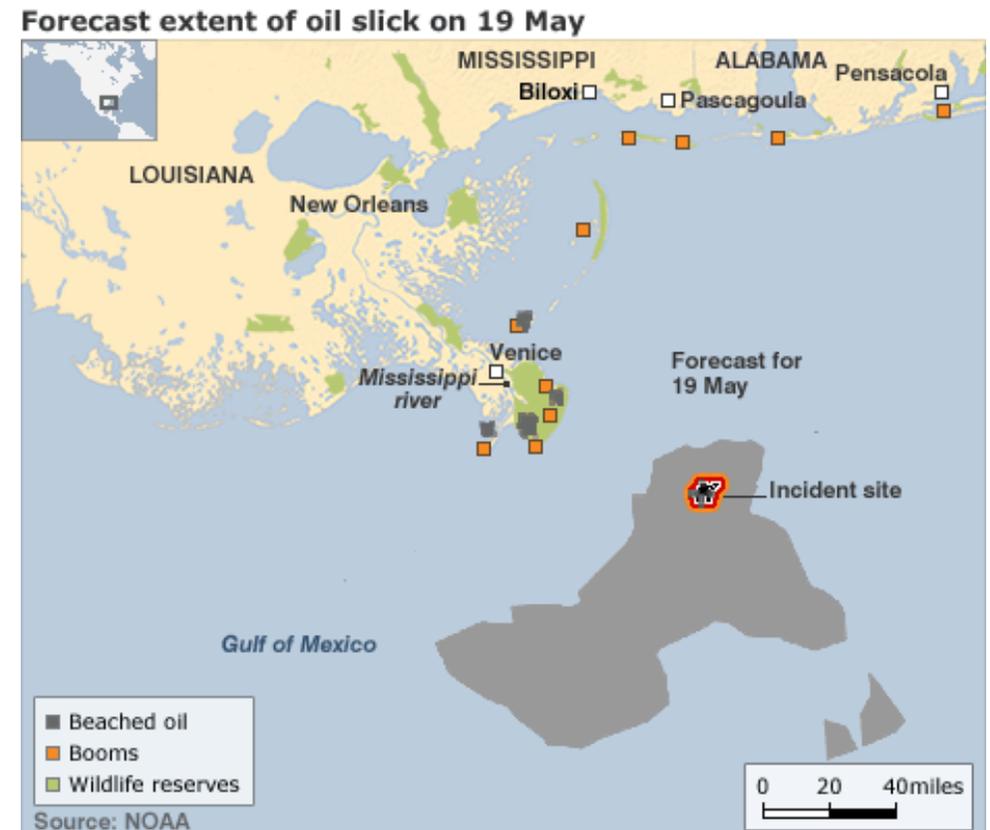
What went wrong?

- The mud was removed from the riser and replaced with water
 - Done *before* final cement plug was set, for unknown reasons
 - Much lower density → bottomhole pressure decreased
- Gas then entered the wellbore
 - Should have been impossible due to cement layer
 - Gas rapidly expands, forming bubbles
 - Resulting in ever lighter column → blow-out!
- BOP was activated but did not close fully
- Uncontrolled gas production
 - Gas ignited
- Rig sank after burning for several days
 - Riser containing drill pipe still attached
- Massive oil spill was formed
 - Leak of at least 5000 bbl/day

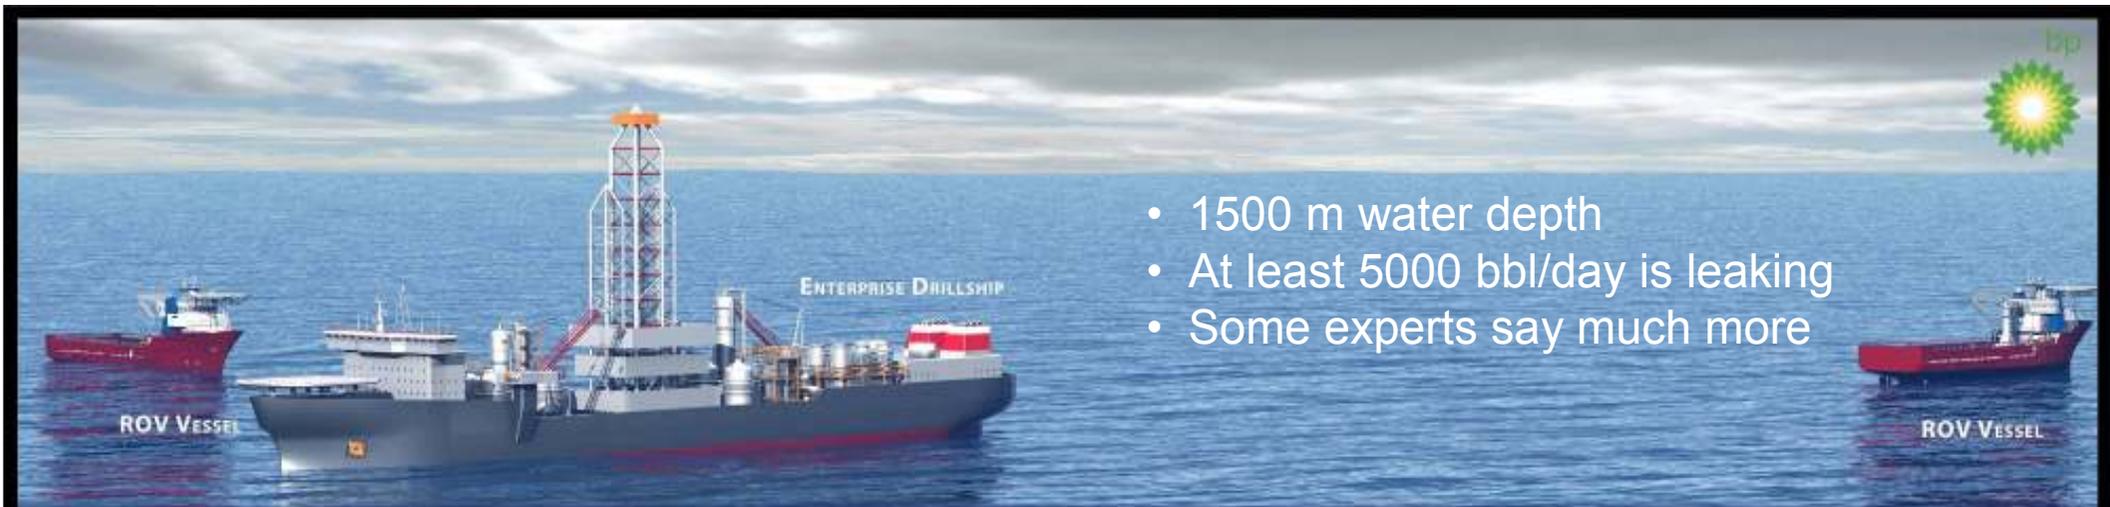
Situation on the sea bed

- 1500 m water depth
- At least 5000 bbl/day is leaking
- Some experts say much more

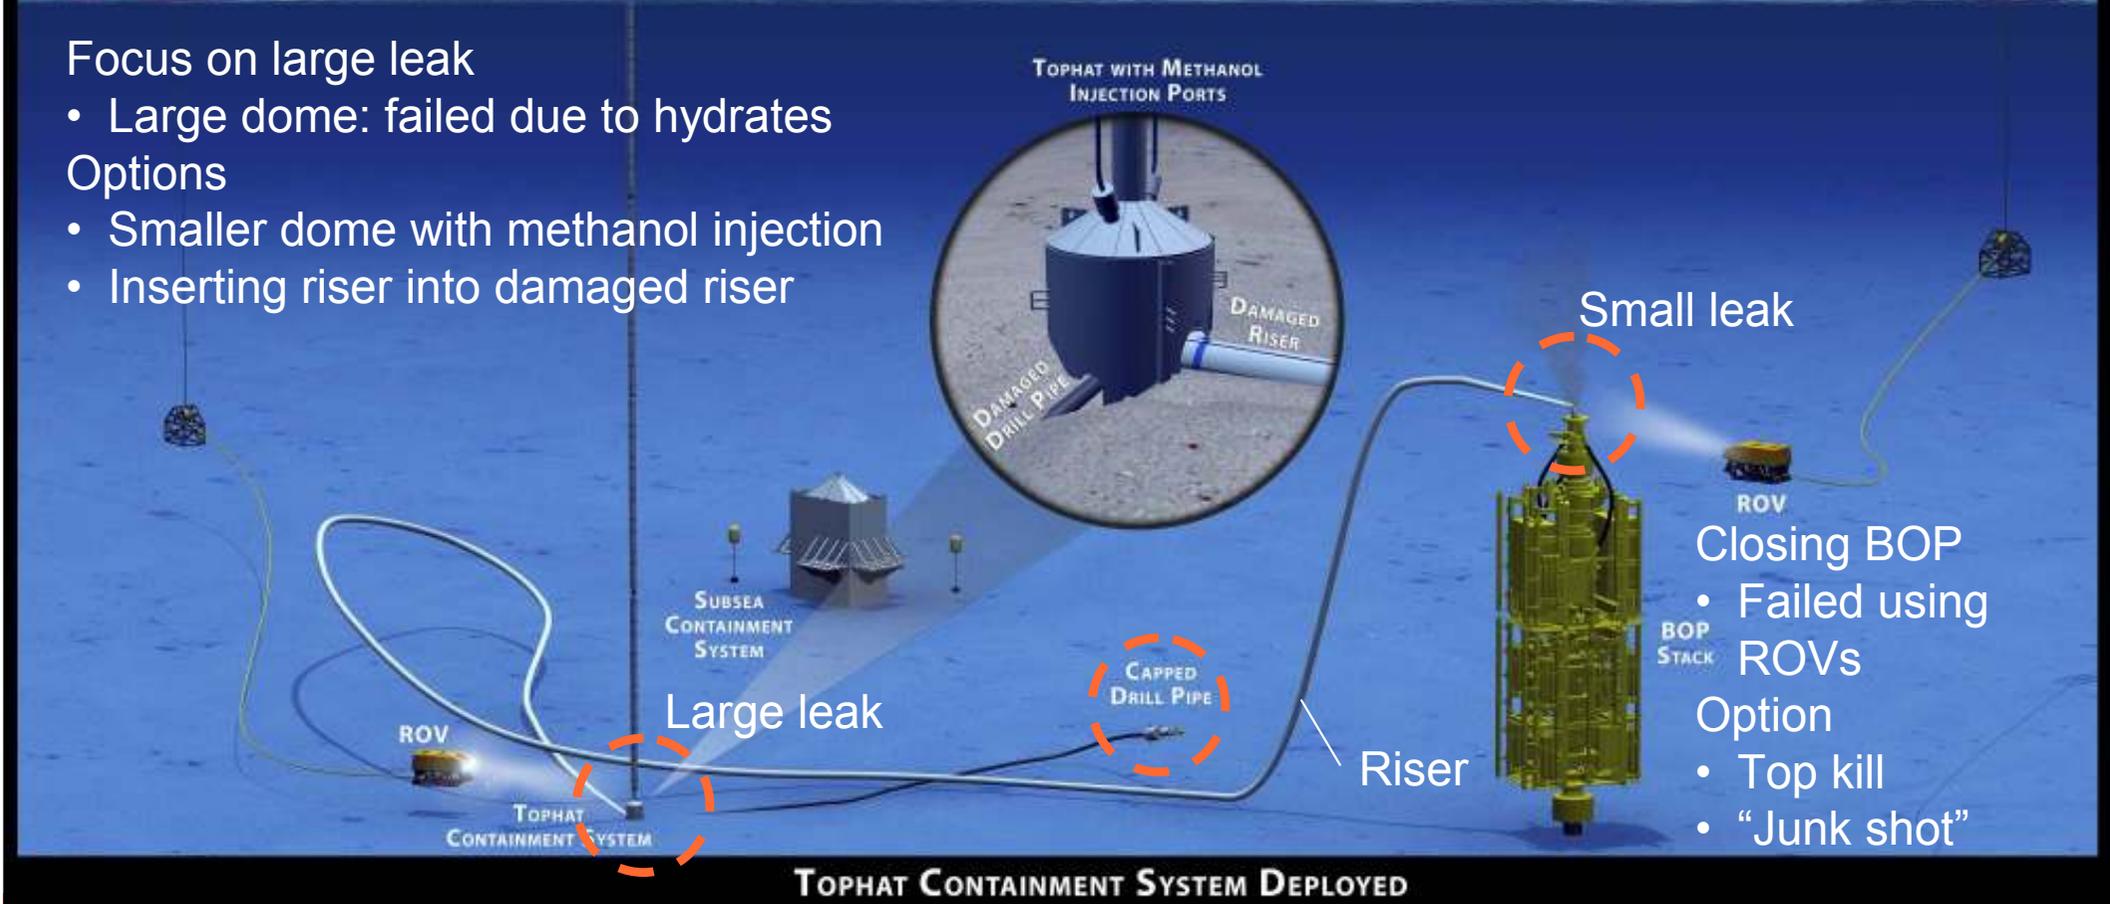
Focus on large leak

- Large dome: failed due to hydrates
- ### Options
- Smaller dome with methanol injection
 - Inserting riser into damaged riser

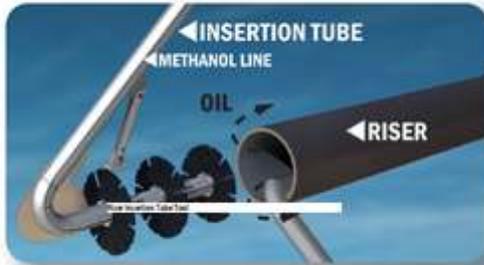
1 Insertion tube is guided into riser.

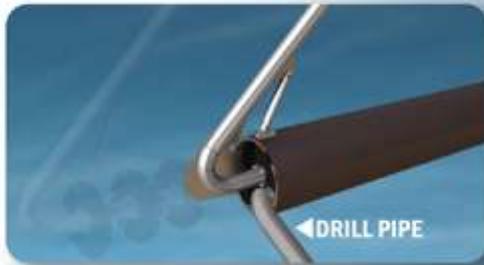
2 Rubber diaphragms conform around drill pipe to plug riser as much as possible.

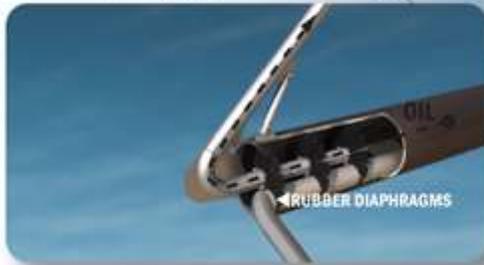
3 Hydrocarbons are then flowed to the drillship.

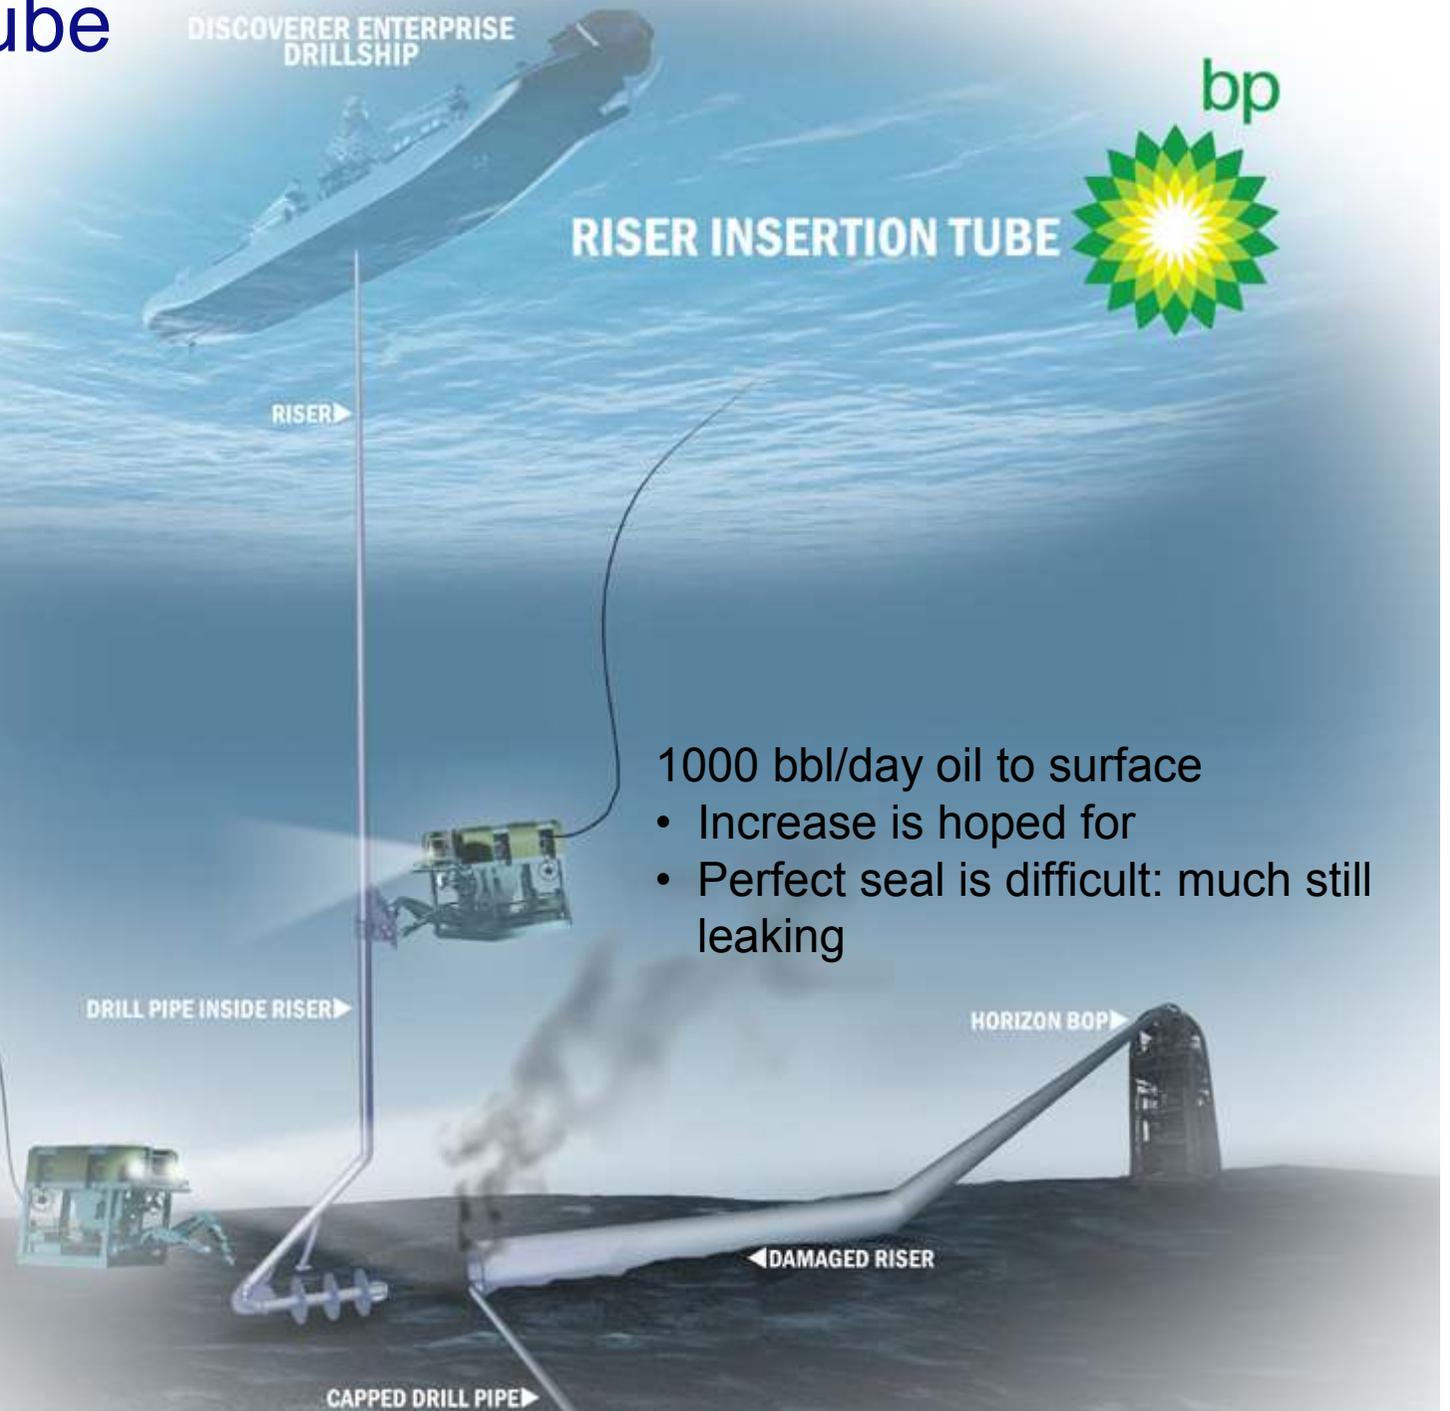
1000 bbl/day oil to surface

- Increase is hoped for
- Perfect seal is difficult: much still leaking

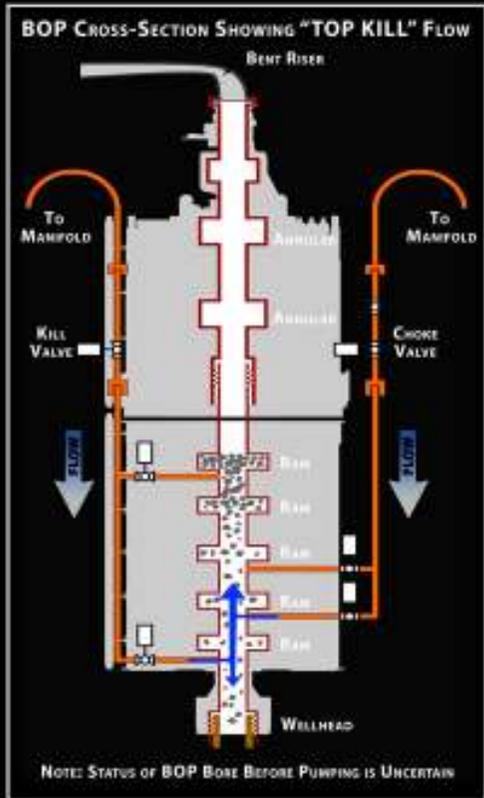
If necessary, rubber material injected into BOP

- “Junk shot”: used on Kuwait’s oil wells during first Gulf War
- Never attempted under 1500 m of water
- Will stop the flow, and then allow heavy mud/cement to kill well

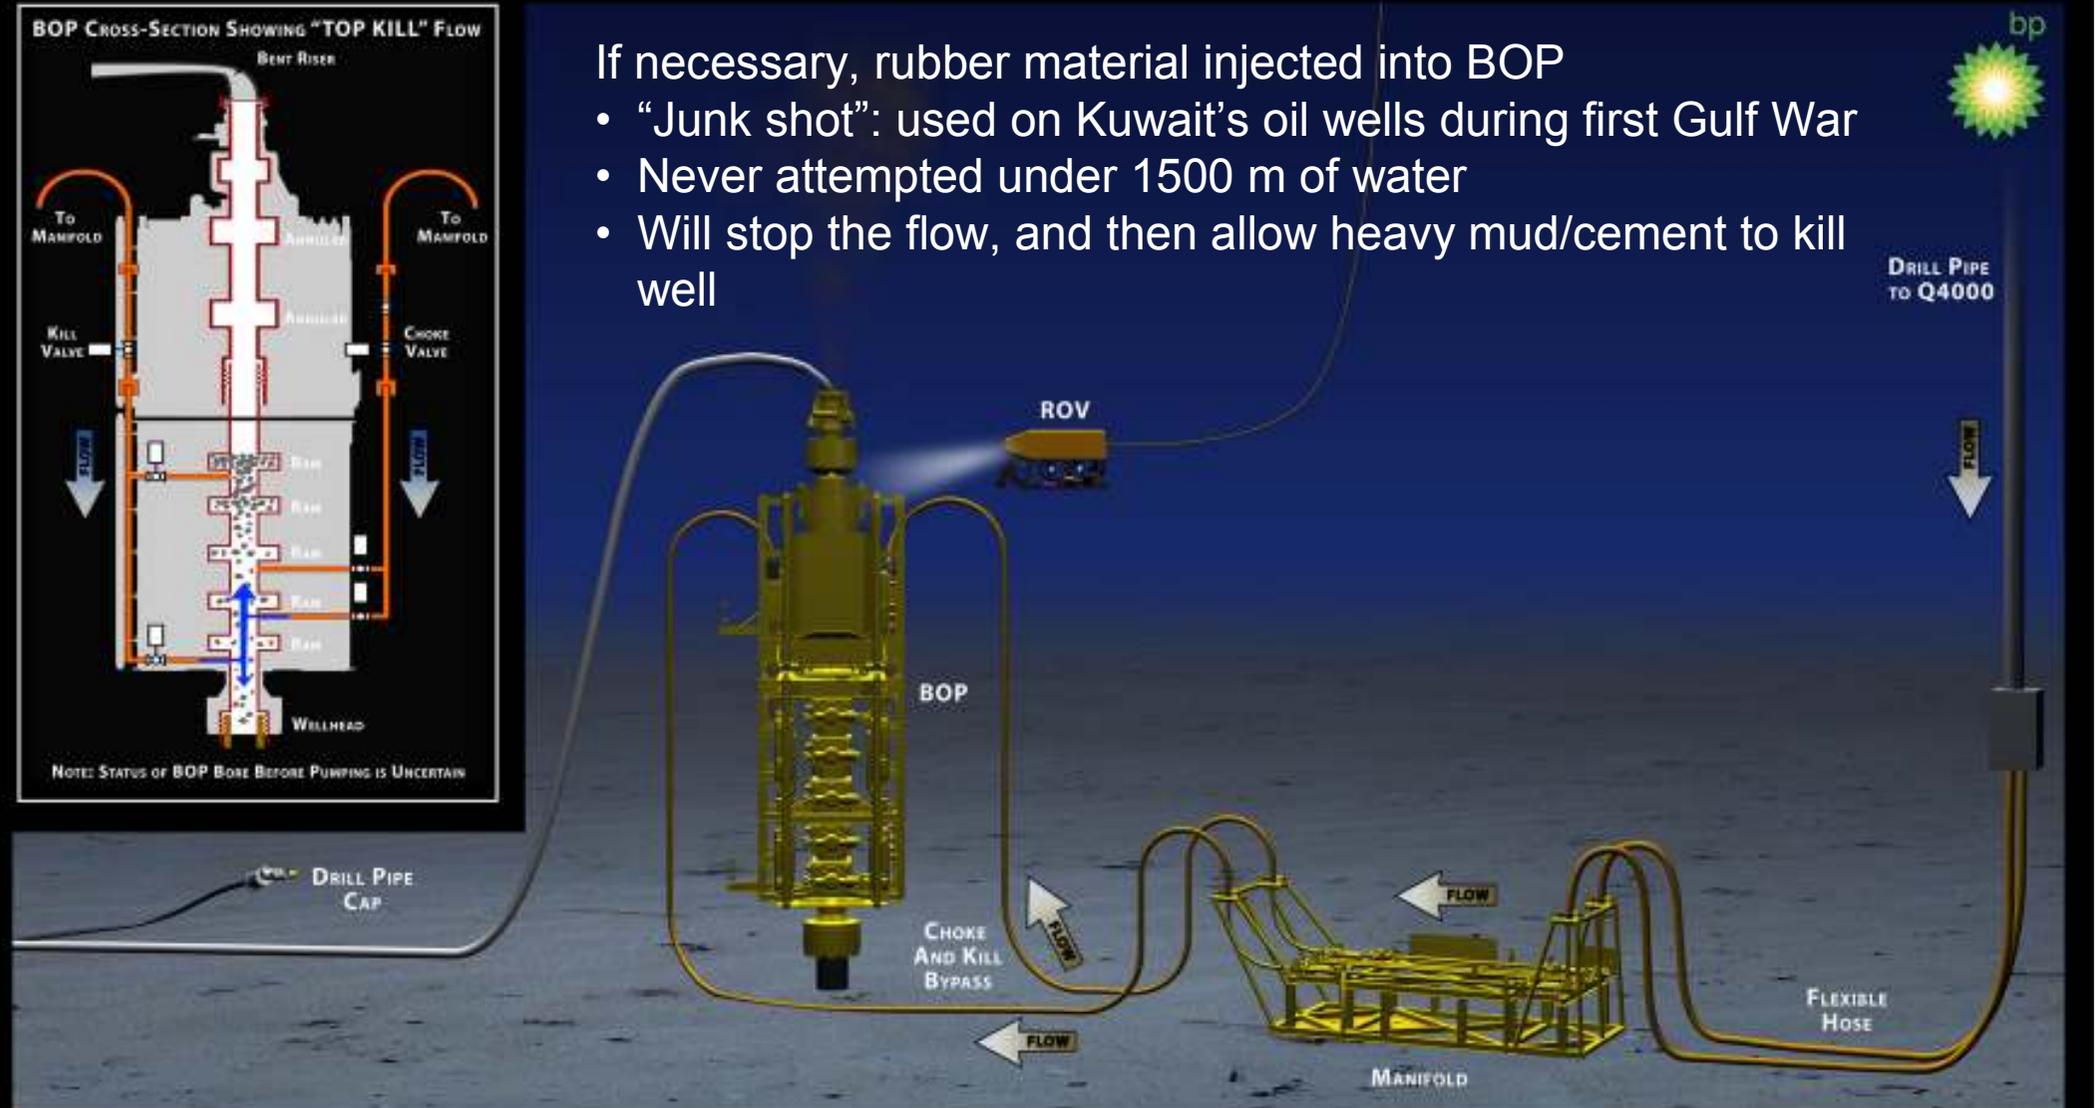
TOP KILL

- Closing BOP will stop the leak: ROVs were unsuccessful
- Top kill: injecting kill fluid (heavy mud) to stop flow
- May only be possible by first plugging BOP: “junk shot”
