**SAFETY STUDY 1/2001**

**REVIEW OF  
LIFEBOAT AND LAUNCHING SYSTEMS'  
ACCIDENTS**

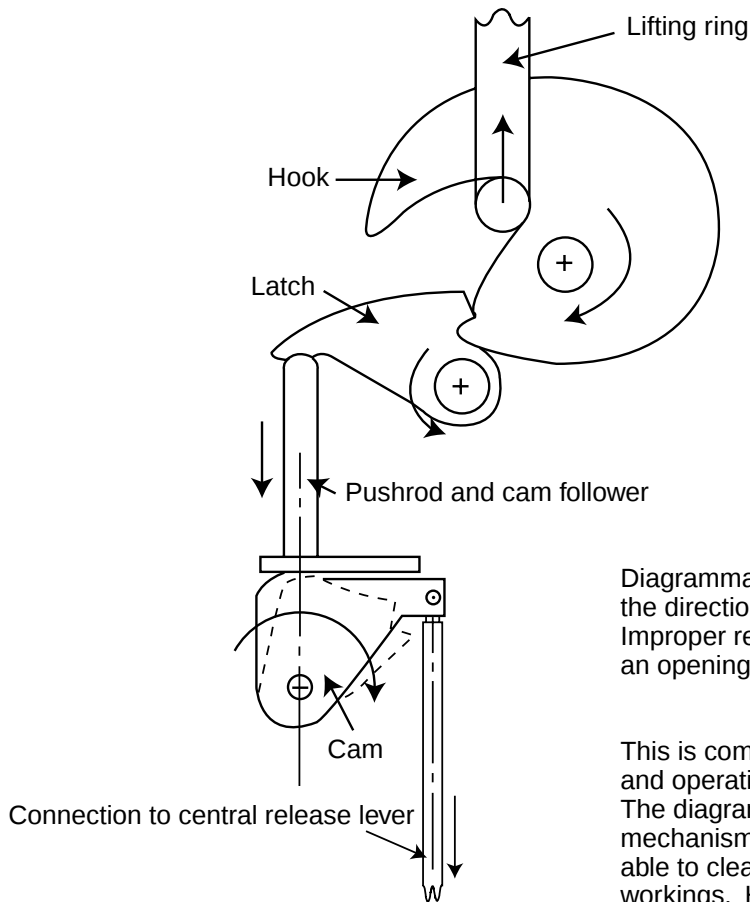
Figure 1

It has been found that crews generally have a poor understanding of the operating principles involved with release hooks, often because of inadequate training. This is not the only reason. Poor labelling, complex mechanisms and hard to follow operating instructions in some manufacturers' manuals have also featured as contributing factors **(see Figure 1)**.

Diagrammatic arrangement of hook release mechanism and the direction of movement of its components during release. Improper resetting of the cam, as shown dotted, can induce an opening moment leading to inadvertent release.

This is compounded by the complexity of the mechanism and operating instructions that are difficult to understand. The diagram, showing the important features of resetting the mechanism, is complicated and makes it necessary to be able to clearly see the actual mechanism to understand its workings. However, viewing the mechanism is difficult, making understanding of the diagram difficult. Other material in the manufacturer's instruction manual was of little help in this task.

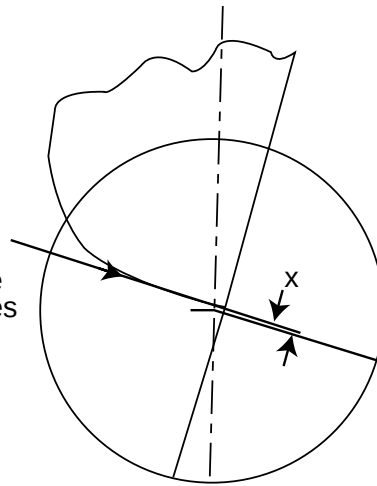
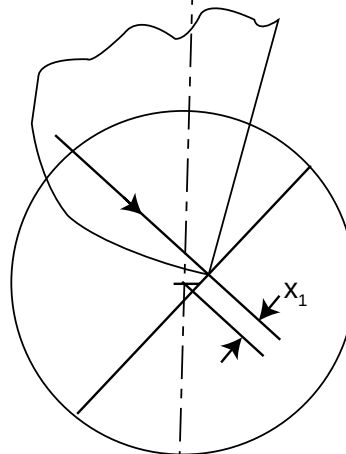
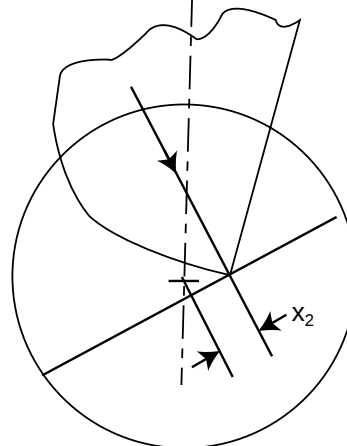
Figure 2

Analysis of a number of accidents reveals that premature hook release has often been caused by the failure to re-set it correctly when the lifeboat was being recovered from its previous launching. This shortcoming stems from a lack of understanding of the mechanism involved, inadequate training and poor maintenance. Once the hook has been incorrectly reset, spontaneous release is possible at any time before the lifeboat is next put in the water **(see Figures 2 and 3)**.

Hook and cam in fully closed position. Flat face of cam and tail of hook are in contact. This gives the minimum lever 'x' by which the force from the hook's tail generates an opening moment on the cam. This moment is resisted by the moment generated by the cable force.

Partially closed condition. Improper resetting of the cam when a boat is being recovered might generate this state. Can be aggravated by sticky cables. The size of the lever ' $x_1$ ' is much greater than that for the fully closed position 'x'. This allows the force from the hook's tail to generate a much larger opening moment on the cam. It is possible for this moment to overcome that generated by the cable leading to rotation of the cam and spontaneous opening of the hook.

Further rotation of the cam leads to increase in the size of the lever to ' $x_2$ '. The moment generated on the cam is so large that it will almost certainly overcome the moment generated by the cable force. The hook is then able to fully open.

The above sequence shows the magnification in hook opening effects due only to the growth in lever of the force in the hook's tail. Other changes take place as the cam's face rotates, which result in an increase in magnitude of the hook's tail force and thus also the cam rotating moment. All of these effects indicate the importance of properly resetting the cam when recovering a boat.

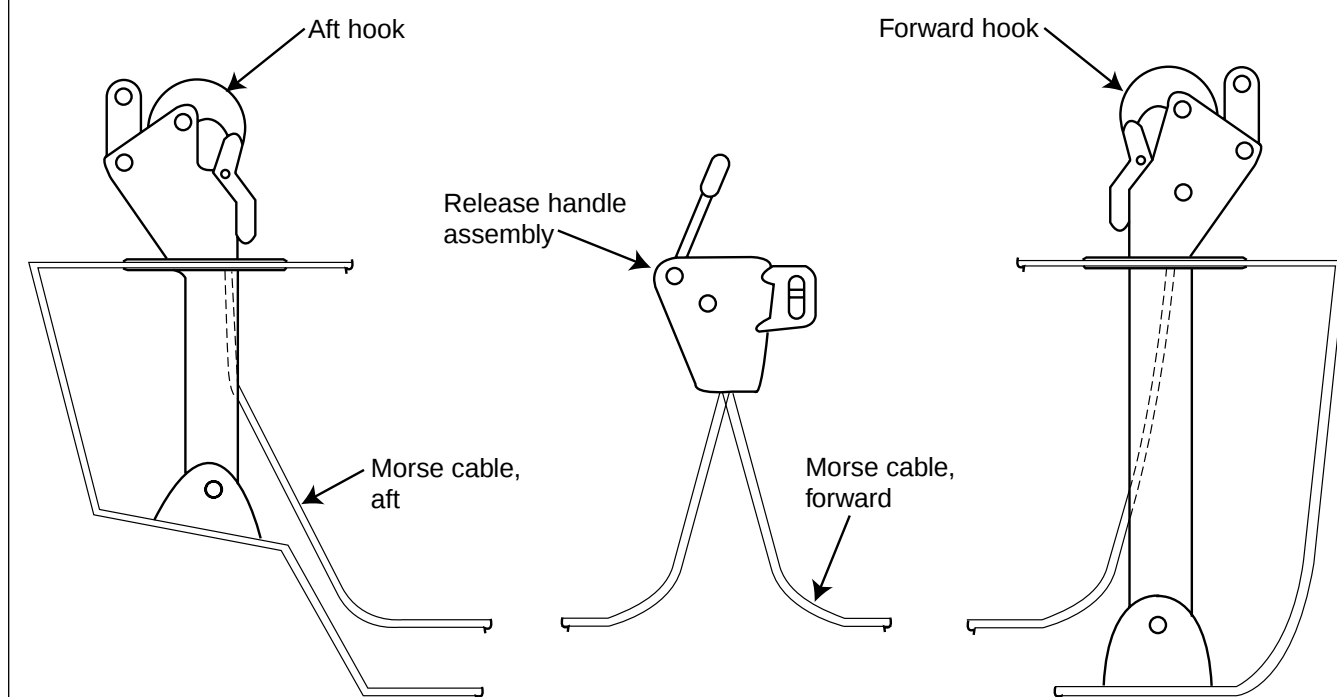
Figure 4

To comply with the requirement that both hooks are released simultaneously from a single control position, it is common for release mechanisms to include flexible cables to connect the control lever to the hook mechanisms (**see Figure 4**).

The MAIB has found, however, that these cables can seize if the stranded wire becomes corroded. This can result in the on-load release hook failing to close properly when being reset. This in turn has resulted in inadvertent release later. Once corroded these cables cannot be repaired effectively, and have to be replaced. The evidence shows that management and crews are often unaware that such replacement is necessary.

In response to one MAIB recommendation, a manufacturer amended its on-load release hook operation and maintenance manual to emphasise the importance of replacing damaged or corroded cables. It is not always the case. It is known that some other manufacturers do not draw attention to the inherent dangers of not replacing corroded cable.

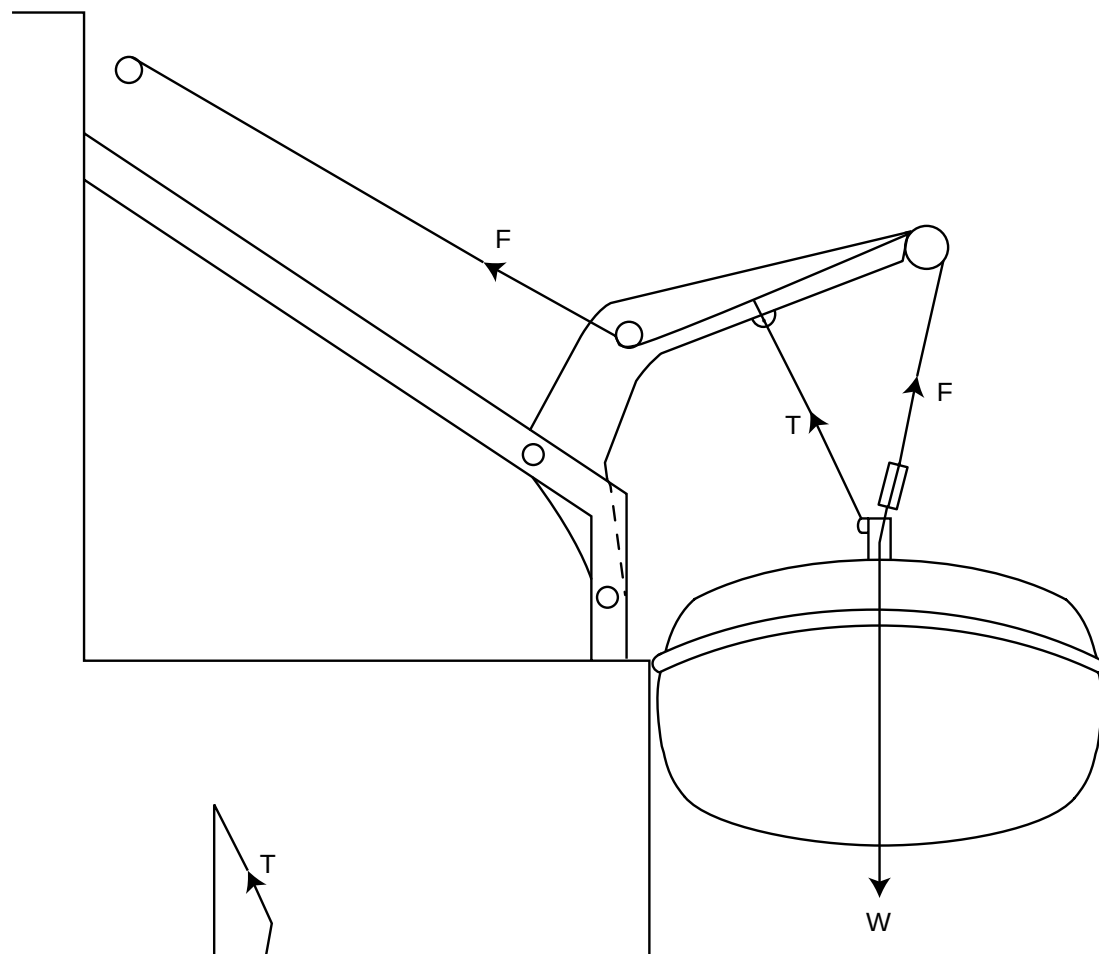
Figure 5

Launching procedures call for the lifeboat to be lowered to embarkation level while the tricing pennants pull it into the side of the vessel (**see Figure 5**). Once at the correct level, bousing tackles are secured between the forward and aft lower blocks and the ship (**see Figure 6**). When tightened they take over the function of the tricing pennants, which are then disconnected.

Lifeboat lowered to embarkation level. Winch is stopped at a position such that the tricing pendants have pulled the boat almost into contact with the ship's side, or in very light contact only. The boat's weight (W) is shared between the tricing pendants (T) and the falls (F). Note that the tricing pendant load (T) is noticeably less than the boat's weight (W).

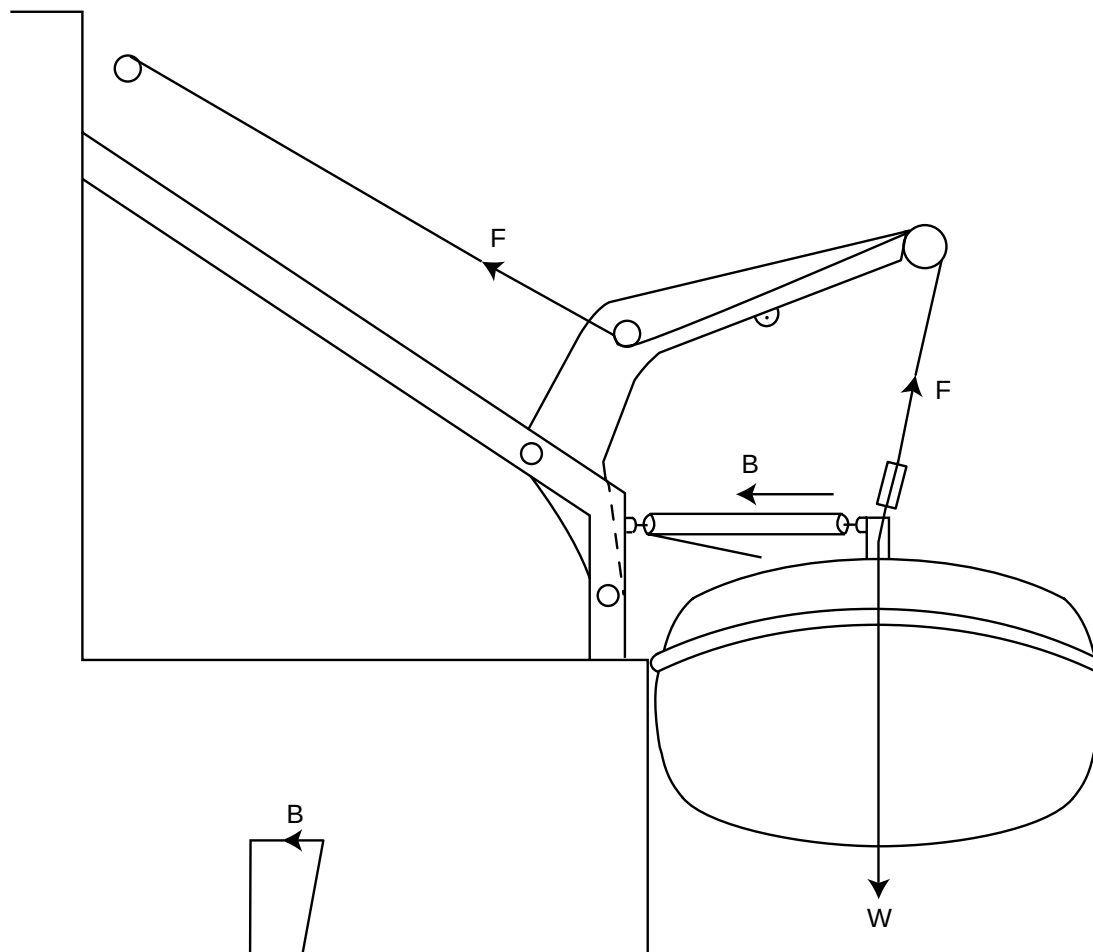
Figure 6

Lifeboat lowered to embarkation level, triced in and the bowsing tackles fitted. Once tricing pendants are slipped, properly tensioned bowsing tackles retain the lifeboat into the ship's side. Because the bowsing forces are virtually horizontal, only the falls load ( $F$ ) supports weight ( $W$ ), as intended. Also,  $F$  is acting in the back falls and contributes to the support of the davit arms.

This process can be time-consuming while the bowsing tackles can be heavy and awkward to handle, particularly on high capacity lifeboats. Investigations have shown that the full bowsing-in procedure is often ignored during crew exercises.

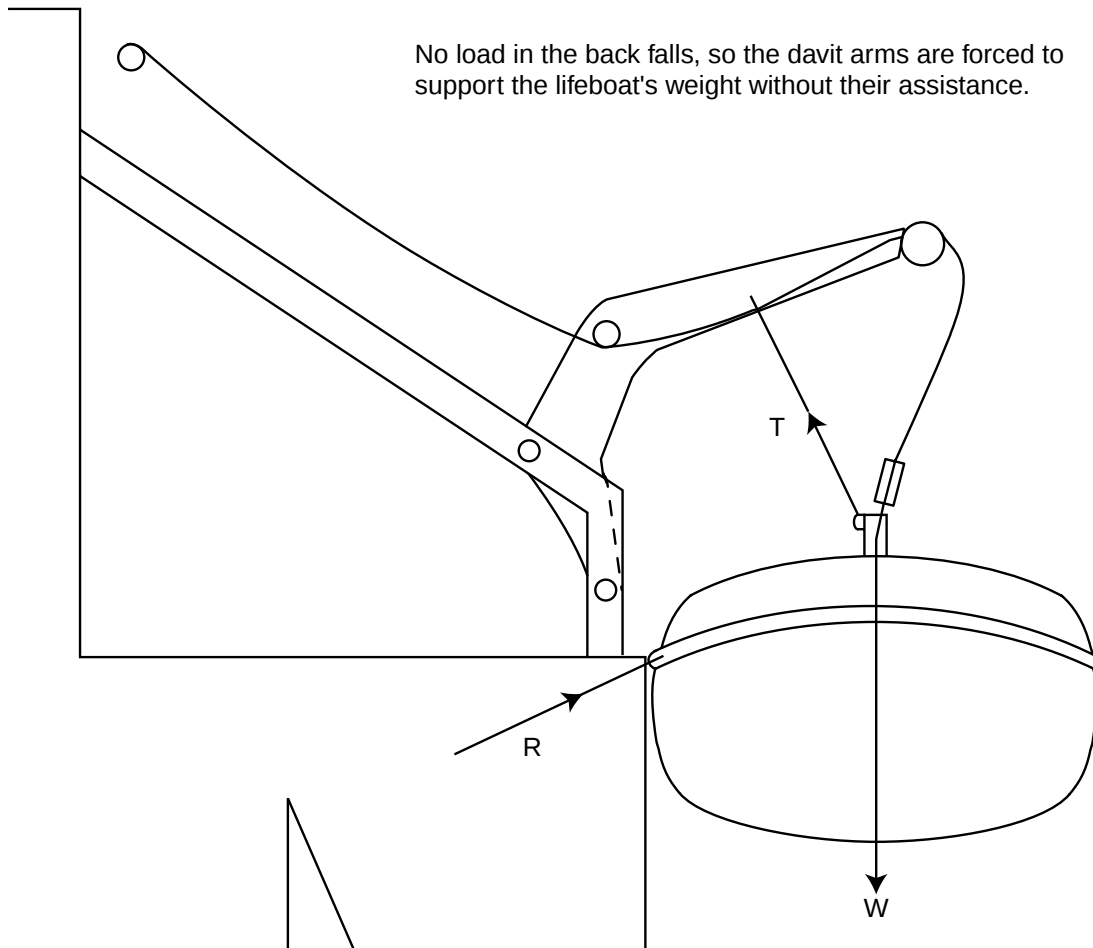
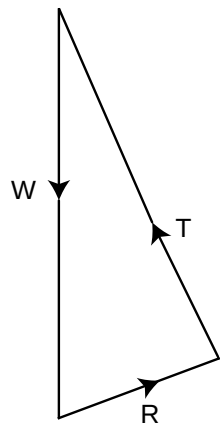
Figure 7

A second potential danger of not bowsing in a lifeboat is that a loaded lifeboat might overload the tricing pennants. If they fail (**see Figure 7**), the consequences can be serious. This is likely to occur if the lifeboat is brought hard against the ship's side. It can even lead to the falls going slack if the winch wire is paid out too far. Tricing pennant failure would again cause the boat to swing uncontrollably, endangering anyone who happened to be embarking at that particular moment.

Lifeboat lowered to embarkation level. However, winch is allowed to run to the extreme position where the falls become slack. The boat's gunwale is in heavy contact with the ship's side. The tricing pendants now take the boat's weight ( $W$ ) alone and their loading is much increased. A load that they are rarely designed to take.

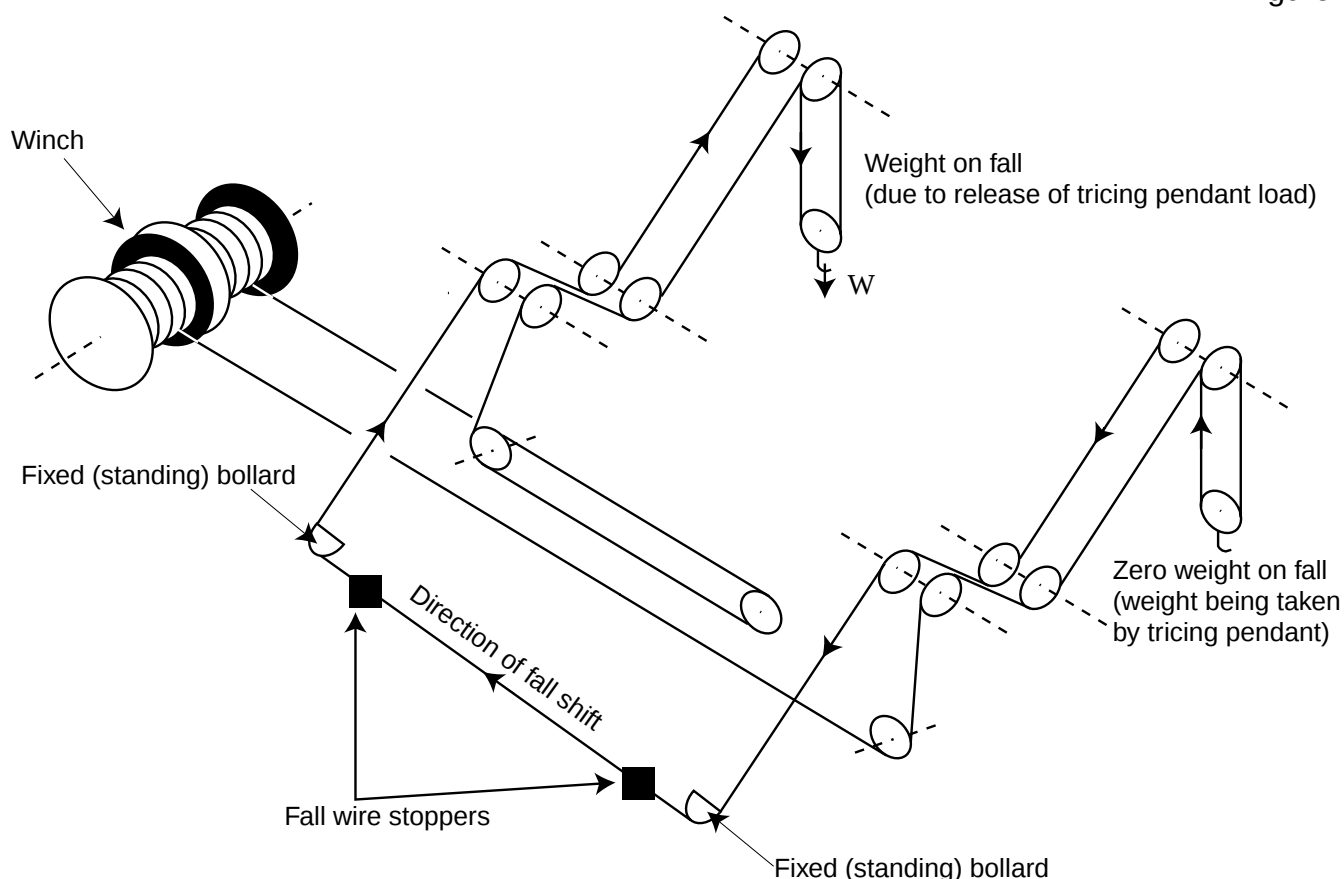
Figure 8

Failure of a single tricing pennant with slack falls has been known to have serious implications. When continuous falls are fitted, they will run out at the end where the failure has occurred. The lower block at the other end will simultaneously rise, sometimes sufficiently far and hard to hit the head of the davit arm. This imposes a dynamic overload on it and may lead to failure with the consequential repercussions for anyone in the lifeboat. This seemingly unlikely train of events has occurred in one boat where the crew was testing experimental tricing/bowsing gear (**see Figure 8**). It was a serious accident and people were killed.

When lowering the boat to embarkation level, the winch might be payed out so far that the falls go slack. Only the tricing pendants then take the boat's weight. Should one tricing pendant then fail, or is slipped, the weight at that end attempts to transfer to the falls. However, as there is no weight on the falls at the other end, because the remaining tricing pendant is still taking it, they can offer no balancing reaction. They then have a tendency to shift or slide towards the end where the tricing pendant has failed. This tendency is normally resisted by friction between the falls and the standing bollards. But, again, without load in the falls no significant friction force can be generated.

The shift may be sudden and might not be resisted by the fall wire stoppers.

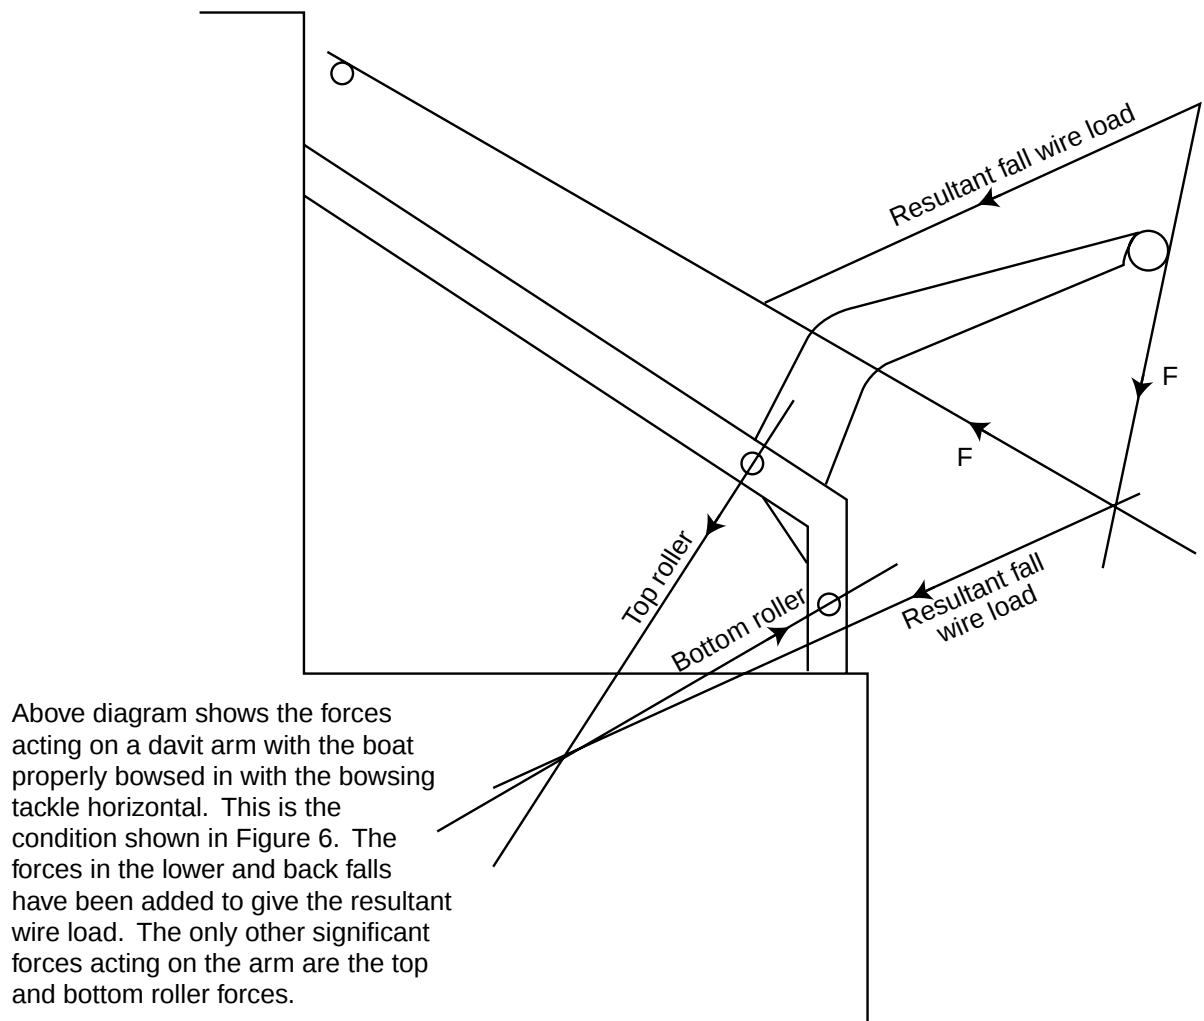
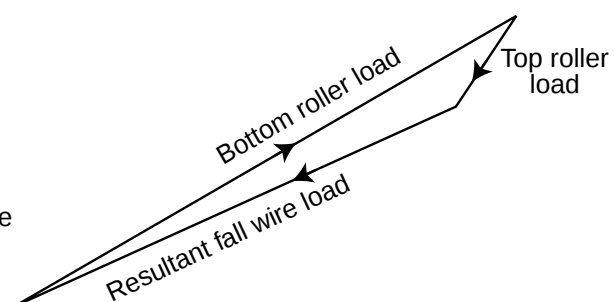
Figure 9

Above diagram shows the forces acting on a davit arm with the boat properly bowsed in with the bowsing tackle horizontal. This is the condition shown in Figure 6. The forces in the lower and back falls have been added to give the resultant wire load. The only other significant forces acting on the arm are the top and bottom roller forces.

The diagram to the right is the above force system giving the relative magnitudes of the forces.

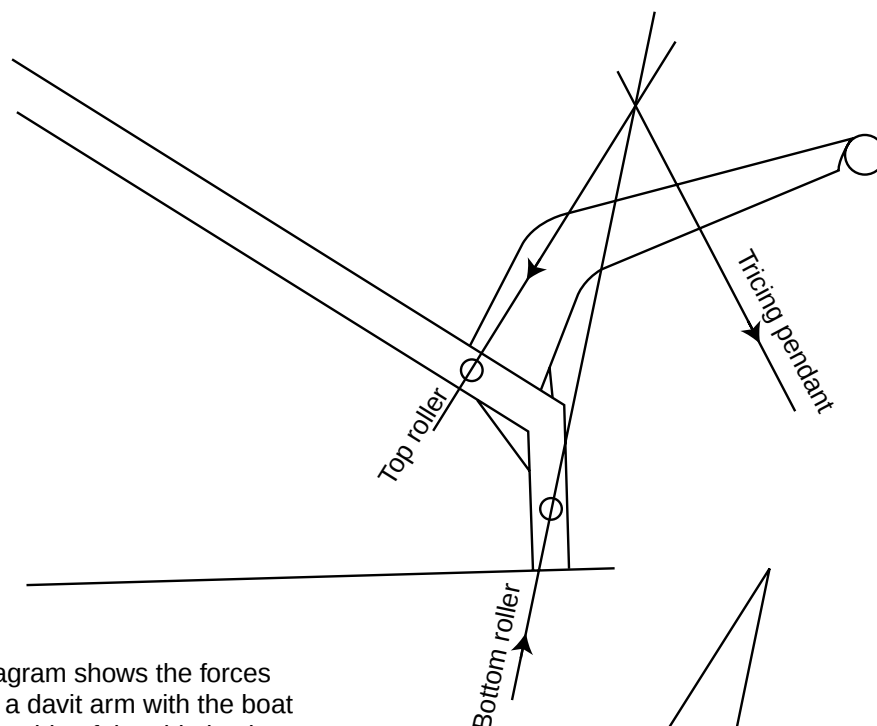
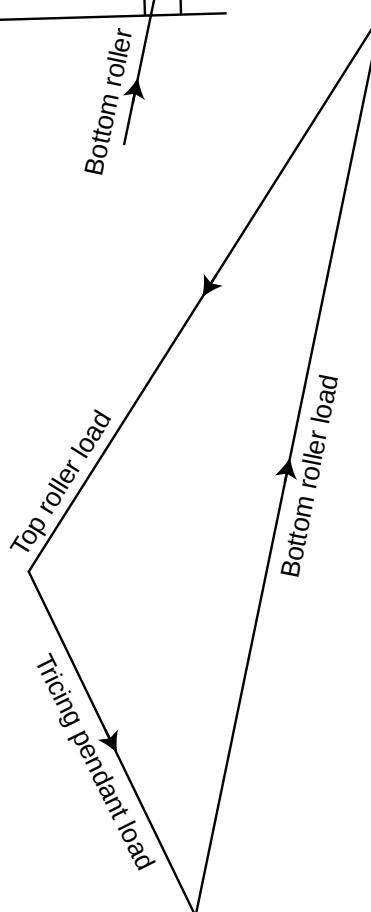
Figure 10

A further consequence of not properly bowing in a lifeboat can occur if the load bearing capacity of the davit arms is dependent on support offered by the back falls which lead inboard from the davit heads (**see Figure 9**). With the lifeboat at embarkation level, and supported by falls and tricing pennants, its weight is shared between them. The greater the proportion of weight taken by the tricing pennants, the less will be taken by the falls. This gives a corresponding reduction in the load on the back falls, which means that their contribution to supporting the davit arm is reduced. This results in an increased portion of the load being taken on the supporting structure of the davit arm and can, on some designs, overload it if the boat is fully laden (**see Figure 10**).

Above diagram shows the forces acting on a davit arm with the boat held to the side of the ship by the tricing pendants and with the falls slack. This is the condition shown in Figure 7. The only significant forces acting on the arm are the tricing pendant load, the top and bottom roller forces.

The diagram to the right is the above force system giving the relative magnitudes of the forces. Notice how much greater are the roller loads compared to the properly bowed in condition of Figure 9.

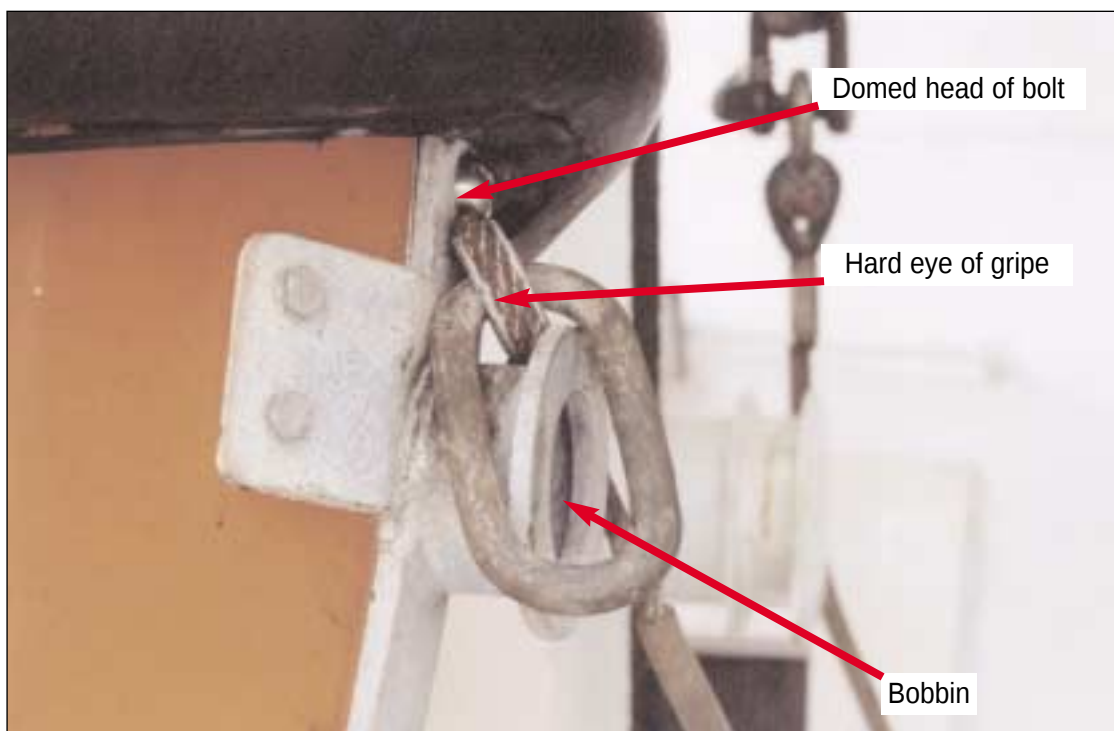
Figure 11

The MAIB received one report where the hard eye on the freed end of a gripe fouled the gripe's bobbin and the domed head of a mounting bolt (**see Figure 11**). This happened during the early stages of lowering. Fortunately it happened during an exercise where there was someone available on the vessel to free the gripe. Had this occurred in different circumstances, the lifeboat could have been loaded, lowered clear of its davits, and yet been prevented both from being lowered to the water and raised under control of the people in the lifeboat. Changing the size of the hard eye allowed the gripe to slide freely over the bobbin and cured the problem.

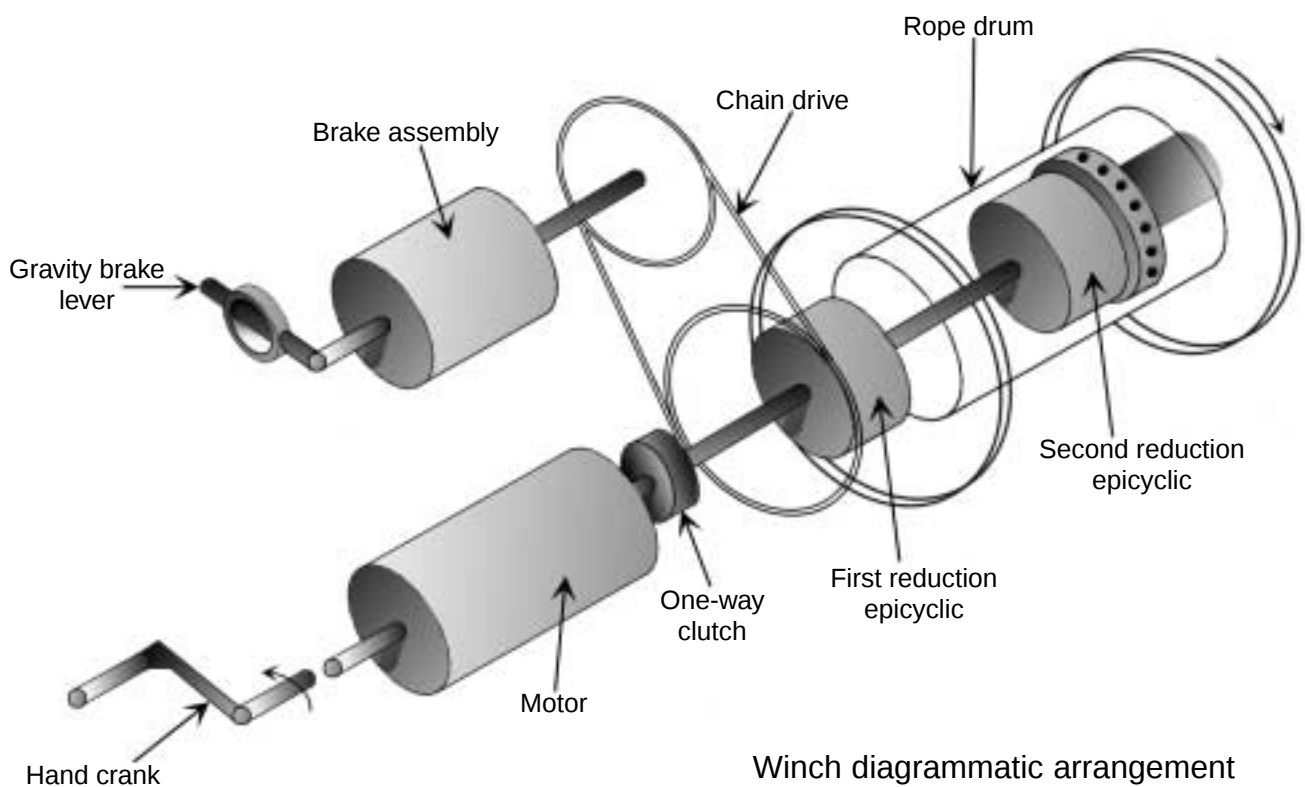
Figure 12

During the 1960s several new designs of winches were submitted to the UK Administration for approval. Some employed one-way sprag-type clutches. These used smooth inner and outer tracks, and relied entirely on friction forces to lock the unit. Carefully shaped spring-loaded sprags within the annular space between the tracks, generated the locking forces. These units ran free when one half of the unit turned, and locked when opposite rotation was applied.
