The sinking of the Sleipner A offshore platform

Excerpted from [SINTEF, Civil and Environmental Engineering](#):

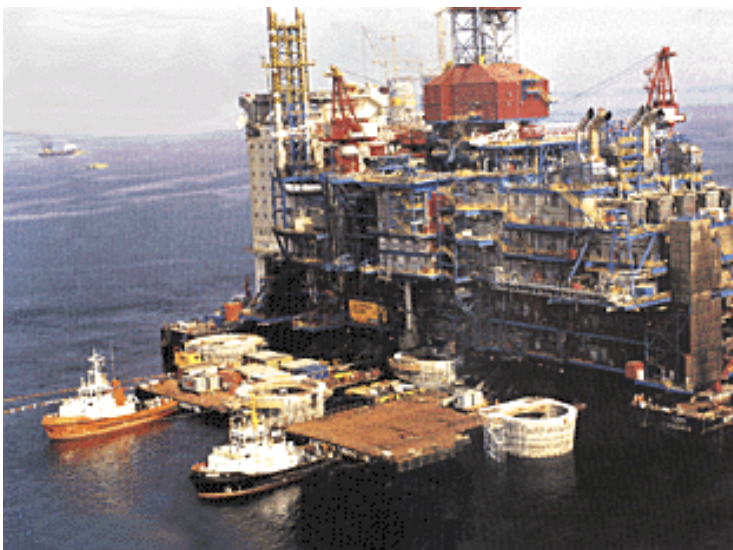
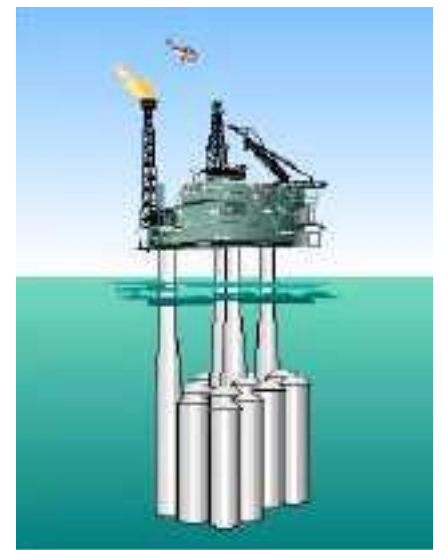
A better idea of what was involved can be obtained from this photo and sketch of the platform. The top

deck weighs 57,000 tons, and provides accommodation for about 200 people and support for drilling equipment weighing about 40,000 tons. When the first model sank in August 1991, the

crash caused a seismic event registering 3.0 on the Richter scale, and left nothing but a pile of debris at 220m of depth. The failure involved a total economic loss of about \$700 million.

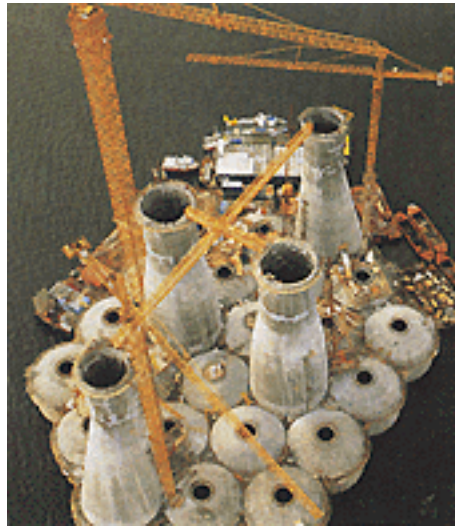
The conclusion of the investigation was that the loss was caused by a failure in a cell wall, resulting in a serious crack and a leakage that the pumps were not able to cope with. The wall failed as a result of a combination of a serious error in the finite element analysis and insufficient anchorage of the reinforcement in a critical zone.

The 24 cells and 4 shafts referred to above are shown to the left while at the sea surface. The cells are 12m in diameter. The cell wall failure was traced to a tricell, a triangular concrete frame placed where the cells meet. At right one is pictured undergoing failure testing.

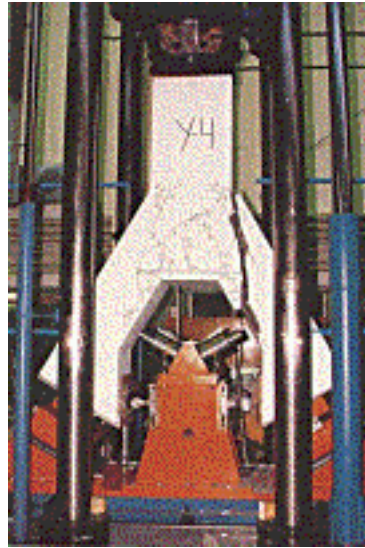
The post accident investigation traced the error to inaccurate finite element approximation of the linear elastic model of the tricell (using the popular finite element program NASTRAN).

The shear stresses were underestimated by 47%, leading to insufficient design. In particular, certain concrete walls were not thick enough. More careful finite element analysis, made after the accident, predicted that failure would occur with this design at a depth of 62m, which matches well with the actual occurrence at 65m.
