Casualty Information

Information from DNV to the maritime industry No. 4 June 2006

Damage to stern tube bearing and seals

Ship type: Tanker Ship size (grt): 80,000–90,000 Year built: 2001

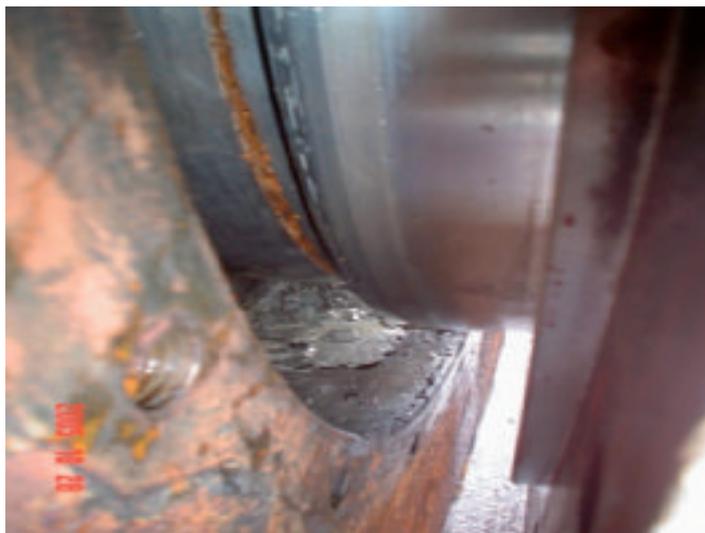
The aft seal was found with the springs broken. Two pieces of the white metal bearing was found loose after the seal was removed, Fig. 1. Further survey of the damage in dry dock verified that the aft stern tube bearing was damaged. The condition of the aft stern tube bearing is seen in Fig. 2. Additionally, the propeller shaft was found to be cracked and bent.

Fig. 1: Pieces of white metal found in the aft stern tube bearing after removal of seal.

The damage to the aft stern tube bearing and propeller shaft is most probably caused by loss of hydrodynamic lubrication due to excessive amount of water in the stern tube oil.

Firstly, the increase in friction between the propeller shaft and the white metal bearing had heated up and displaced the white metal throughout the entire length of the bearing. Secondly, the increased friction had overheated the propeller shaft, and upon cooling of the shaft longitudinal heat cracks had formed. As a result of the overheating the shaft had also become bent.

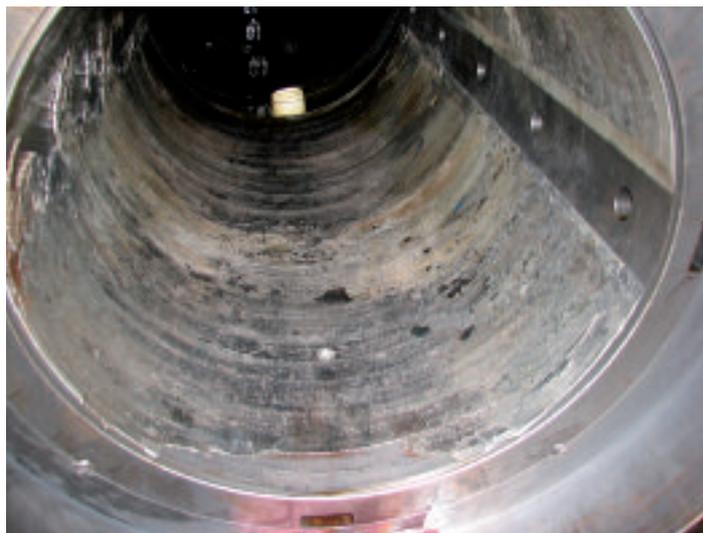
Fig. 2: Condition of white metal bearing found in the aft stern tube bearing.
