Gulf of Mexico Oil Spill

What happened and what is being done to solve the problems?

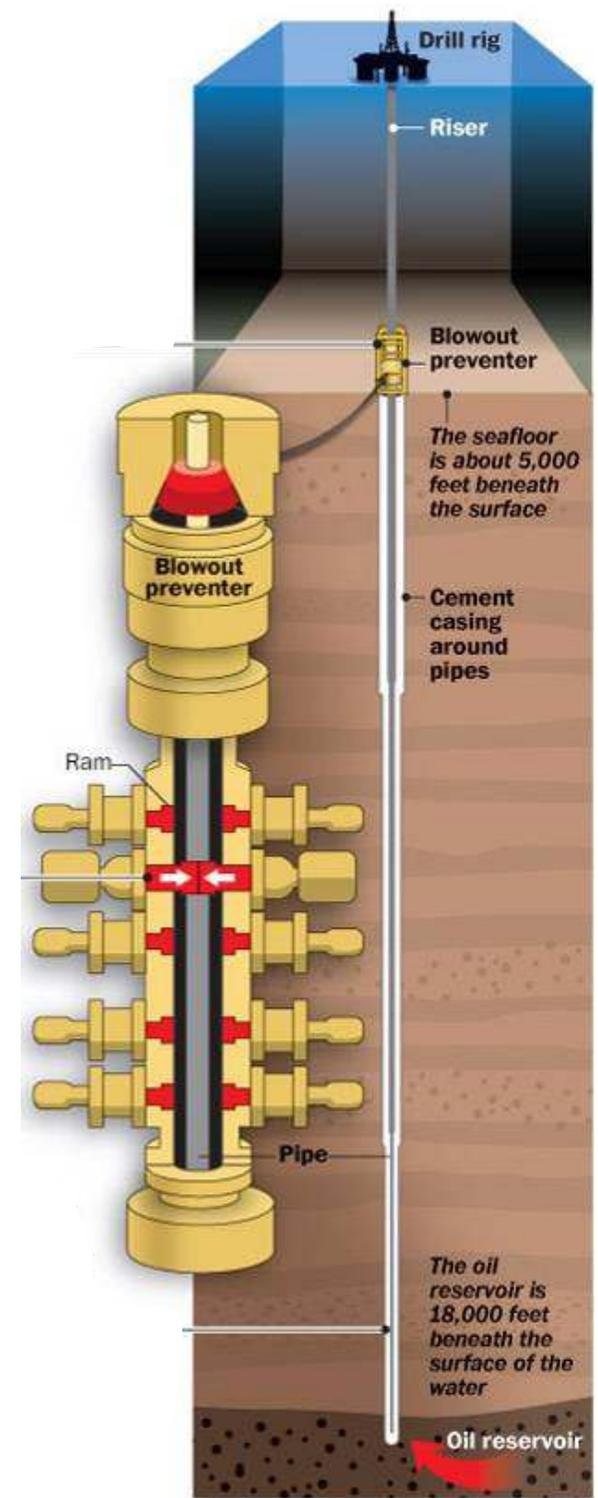
Subsea drilling

- Drill string from platform to bottom of hole
 - Rotated from the top to drill
- Mud is crucial to the process:
 - Pumped down drill string, up around outside annulus
 - Lubricates the bit, removes cuttings
 - Large hydrostatic head prevents inflow of reservoir fluids while drilling: delicate balance!
- If gas enters the wellbore, a blow-out can result
 - BOP is last barrier of defence
- A BOP can close the well in three ways:
 - Closing a seal around the drill string (annular ram)
 - Closing a seal in an empty pipe (blind ram)
 - Cutting the drill string and closing the pipe (shear ram)
