**SAFETY STUDY 1/2001**

**REVIEW OF  
LIFEBOAT AND LAUNCHING SYSTEMS'  
ACCIDENTS**

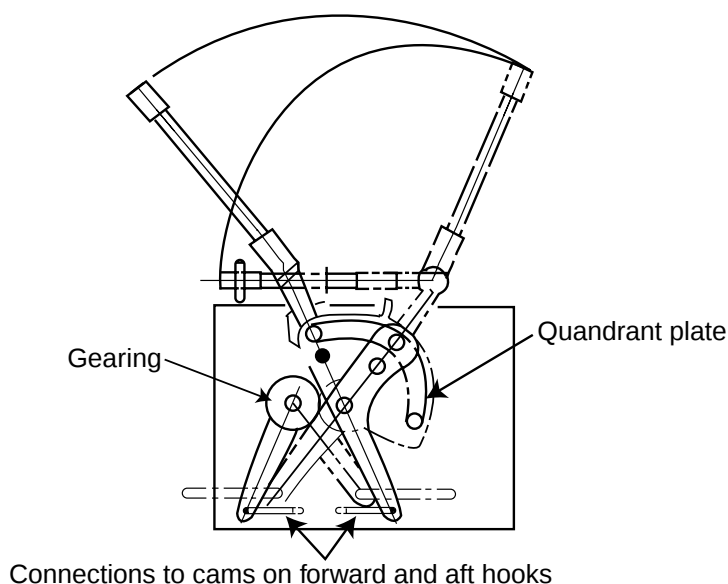
Figure 2

Analysis of a number of accidents reveals that premature hook release has often been caused by the failure to re-set it correctly when the lifeboat was being recovered from its previous launching. This shortcoming stems from a lack of understanding of the mechanism involved, inadequate training and poor maintenance. Once the hook has been incorrectly reset, spontaneous release is possible at any time before the lifeboat is next put in the water **(see Figures 2 and 3)**.

This is compounded by the complexity of the mechanism and operating instructions that are difficult to understand. The diagram, showing the important features of resetting the mechanism, is complicated and makes it necessary to be able to clearly see the actual mechanism to understand its workings. However, viewing the mechanism is difficult, making understanding of the diagram difficult. Other material in the manufacturer's instruction manual was of little help in this task.

The central operating lever is placed adjacent to the coxswain's position, often in such a fashion that the gearing, quadrant and very important safety pin cannot be viewed easily. Indeed it is often impossible for the user to obtain the same view of the mechanism as it is shown on the instruction panel, he can see it only from above, making the important components difficult to identify. This problem is aggravated by these parts being below the bottom boards of the boat in an area of darkness.

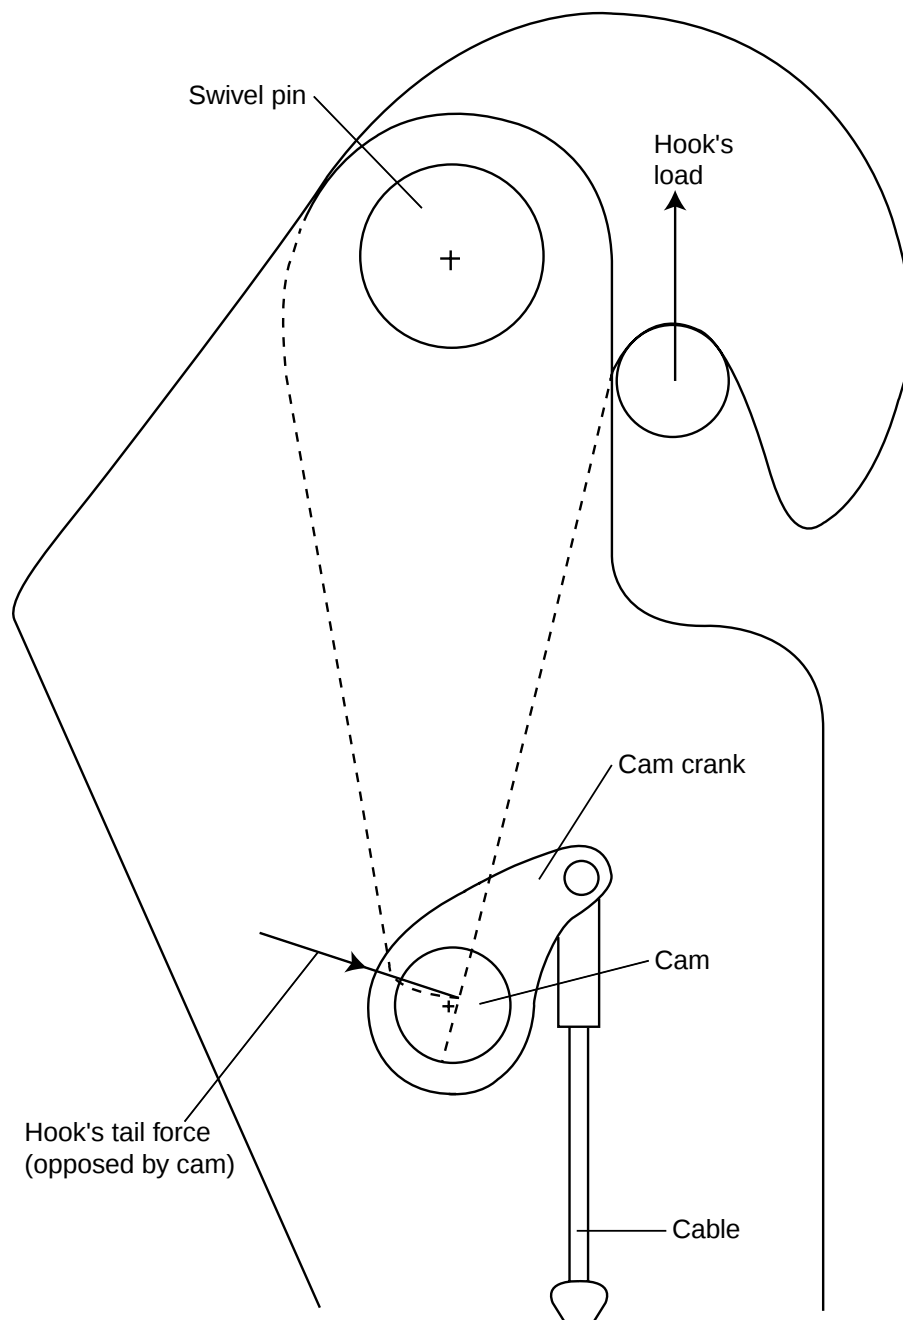
Hook and cam in fully closed position. Flat face of cam and tail of hook are in contact. This gives the minimum lever 'x' by which the force from the hook's tail generates an opening moment on the cam. This moment is resisted by the moment generated by the cable force.
